Risk Mapping Associated With Mass Movements in Viçosa
(MG) Urban Area

Master Leandro Antônio Roque

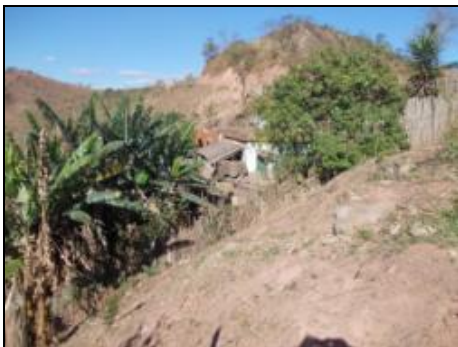
Point 58

The photos presented in Figure 4 (point 58 and 59, respectively) shows, as an example, access roads without any pavement and drainage system, on the top of a high slope, with houses of low constructive pattern, with exposed soil and presence of banana trees that are well known for its overloading effects due to accumulation of water in their roots. This set of factors generates instability on the ground and high risk of sliding during rain periods. High-risk areas require structural actions with greater urgency. It is suggested that urban occupation does not establish in these high-risk areas.

Figure 4: Points 58 and 59, classified as high risk (roads located on top of a hilly slope without any pavement or drainage system).

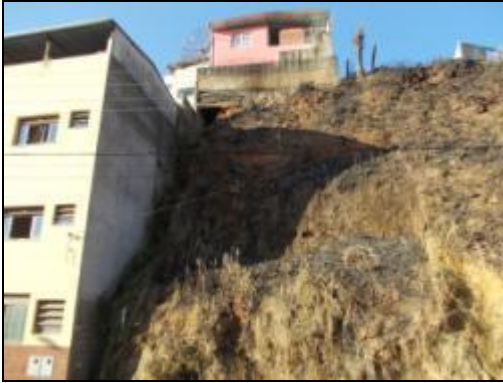
Point 24 - High natural gradient slope

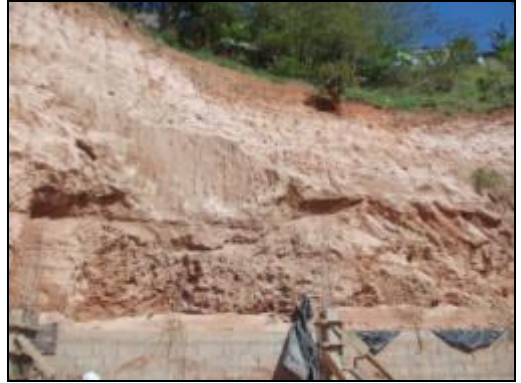
High-risk points (20, 21, 27, 28, 75, 79, 88, and 89) are points that exhibit slopes with high height and declivity, in which there have been landslides. For the high risk point, number 12 – Bela Vista district, the highest risk factor is related to a terrain located at the top of hill with slope greater than 40%, which is used as a irregular dump site by the community. The debris located on this site, associated with the slope of the hill, endangers the population of Rua São José, located on the bottom of the tank.

Point 75 - Cut slope with high declivity

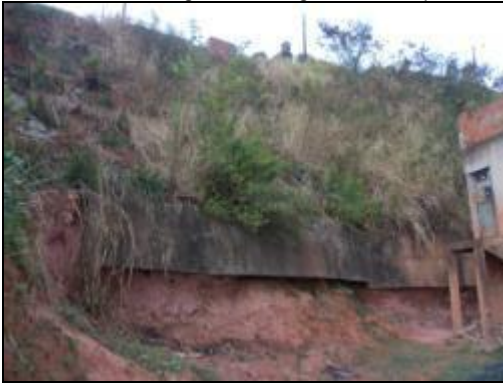
Point 18 - Undermining of contention wall

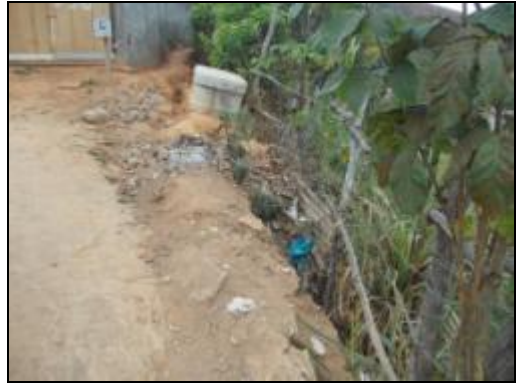
Point 17 - Dump disposal on top of a slope

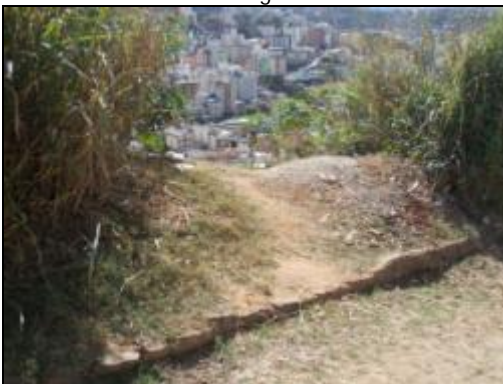
Delimitation of risk area existing in the vicinity of the points 12, 27 and 28 was based on the fact that most of the houses located in the Bela Vista district, especially those located at the top of the slope, and those built below street level, do not have sewage collection, which is simply released downwards.

Point 12 - Disposal of dump on top of a slope

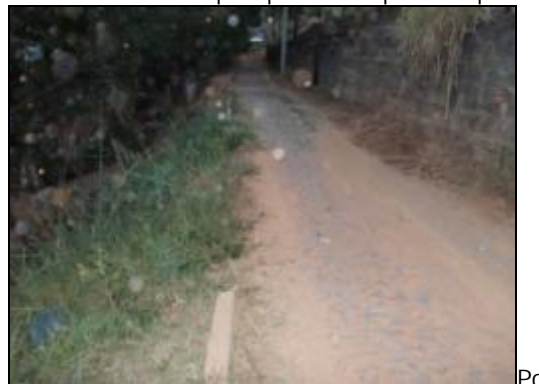
Medium risk points (15, 23, 68, 69, 78, 80) are located in locations of higher declivity, with both natural and artificial drainage systems damaged. Recovering of these drainage systems is necessary to prevent landslides.

Point 15 - Damaged drainage at the top of a slope

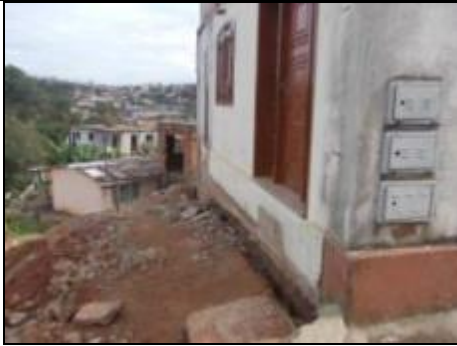
High-risk points number 3 and 5 presents scars of landslides occurred in January 2012, mainly due to the high slope of the terrain - more than 45%, to poor drainage and to buildings constructed to close to slope top. At point number 5 it is also observed, in addition to these factors, the presence of rubble that is played indiscriminately at the top of the slope. At points 7, 37 and 45 the high risk is mainly caused by deficiency in natural drainage and damage of artificial drainage system. In point 45 the lack of drainage is also responsible by erosion processes verified in this local.

Point 03 – Sliding on top of a slope

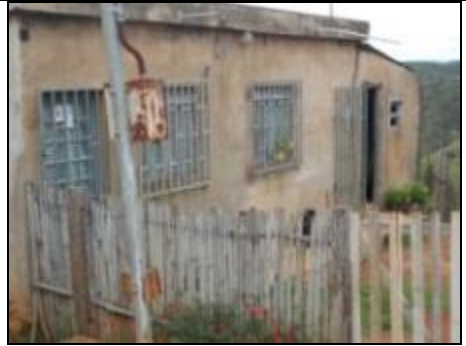
Point 49 - Cracks in home built on a landfill

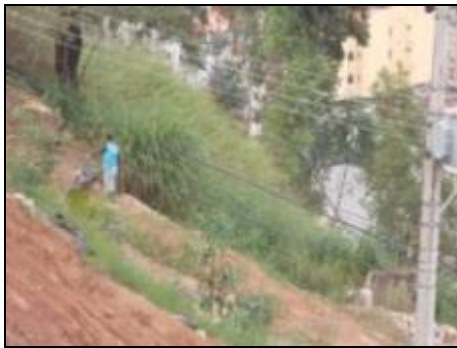
Point 05 - Trash and debris launched on top of the slope

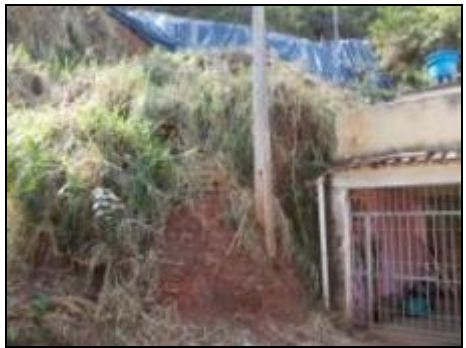
The lack of drainage and paving of streets that are located at the top of the slope are common risk-generating situations observed in points 34, 47 and 53, while the high level of risk observed in paragraphs 35 and 93 is due to the presence of large amount of trash and debris.

Point 53 - Street at the top of the slope without paving and drainage

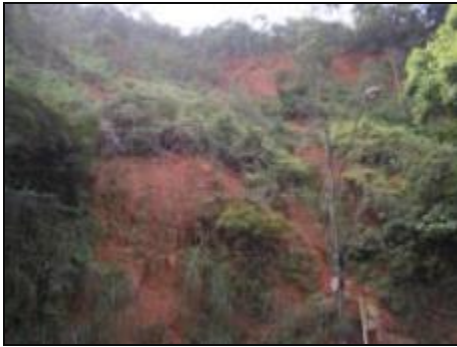
Point 07 - Natural drainage damage system damaged causing landslides

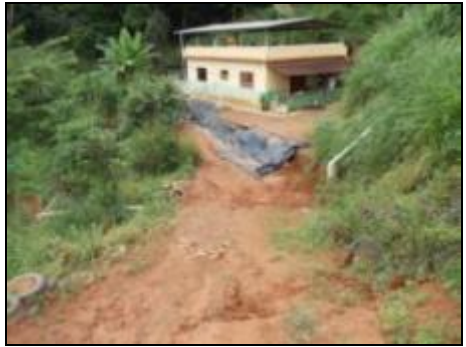
The washout of the creek margin observed in point 92 provoked a great degree of subsidence near a residence, making high the risk of total collapse. At point 33, located on the same stream, excessive rains during January 2012 destroyed a drainage gallery and part of the railway line.

Point 92 - Subsidence caused by margin erosion, on a creek
