Revista Brasileira de Cartografia (2013) N^o 65/6: 1015-1024
Sociedade Brasileira de Cartografia, Geodésia, Fotogrametria e Sensoriamento Remoto
ISSN: 1808-0936

TEMPORAL ANALYSIS OF THE TRANSFORMATION WATERSHED RIVER CRICIÚMA TO ASSIST IN MEASURES FOR MINIMIZING FLOOD

This article aims to present a temporal analysis of the watershed transformation and distortion of Rio Criciúma/SC, Brazil. The methodology includes analysis of legislation, the history of floods, the process of channeling and occupation of the river and aerial photographs, dating to the early development plans in the early 1950s. The results showed that master plans as legally allowed channeling of the river, even though the Forest Code in force since 1934 which contains rules for the preservation of margins of rivers. The occupation of the watershed and river channeling Criciúma have been followed in parallel by flash floods. Aerial photographs show the evolution of channel approach from urbanization and the confinement of River Criciúma which reduced its discharge capacity increasing frequency of floods. It is concluded that these tests provide additional measures to assist in monitoring and control of flash floo

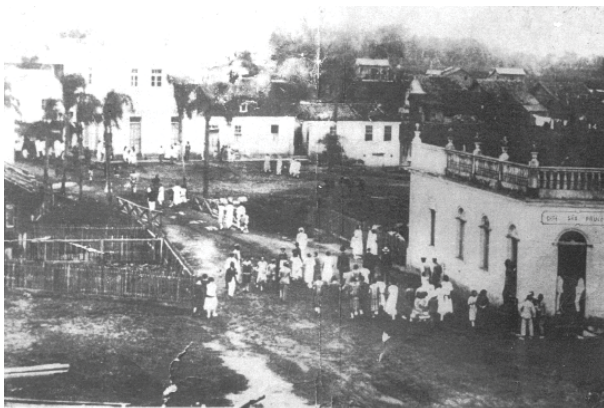
(a) Beginning of the occupation the city on the margins of River Criciúma in 1920. Source: Photo Zapelini

In 1967 comes the first localized flooding in the watershed of the Criciúma river, a fact that became even recurrent and frequent natural disasters that have befallen the city center, changed the view of those who shape economic policy can influence or decisions about the future growth. This neglect is not a privilege of those who today govern the city, the lack of criteria starts in the first movements recorded in the initial plans of land use along with the consolidation of the urban center along the river Criciúma (Figure 2 a, b).

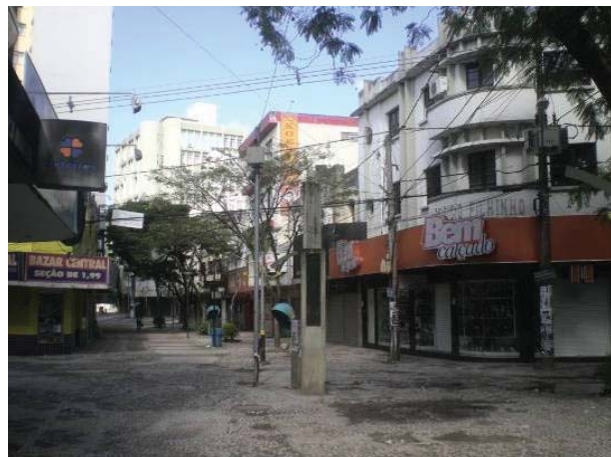
(b) Current Stage of urban occupation in 2011, with the river Criciúma piped and covered by a building. Source: Photo by the author.

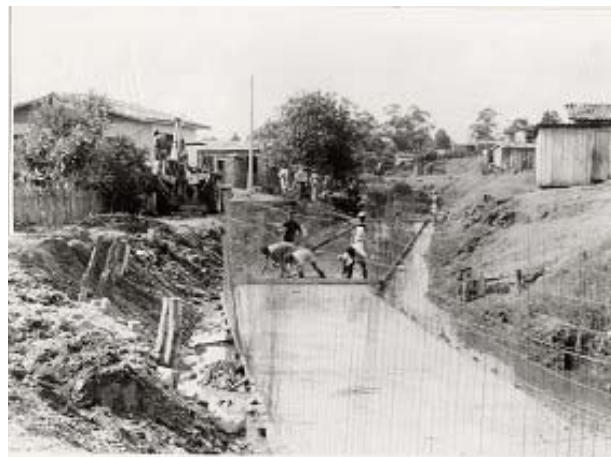
Fig. 3a - Trecho da obra de canalização do Rio Criciúma em concreto armado, década de 1950.

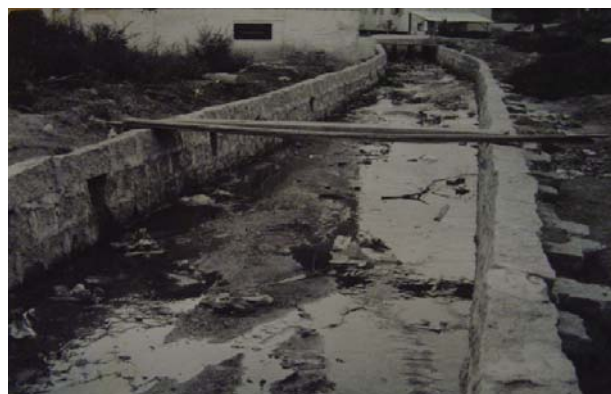
Fig. 3b - Excerpt from the work of canalization of the river Criciúma in granite stone, 1980s.

At the end of the 1950s were beginning, in the city center, the first canalization of the river Criciúma approximation of the buildings to their margins (Fig. 3 b).

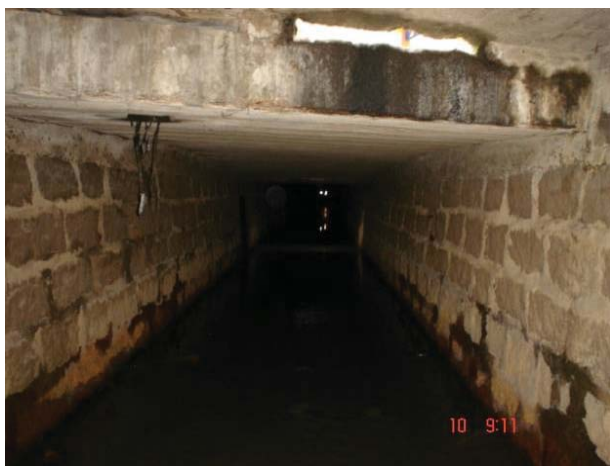
Fig. 4 - Plumbing in Criciúma in 2011 the river, passing under the street. Source: Photo by the author.

On the walls of stone, the river will gradually being covered with concrete slab (Figure 4), confining him completely and the bordering land, adding to the areas that once belonged to river. With the River “hidden” also hides the domestic sewage, solid waste and odor, leaving the space is free to move the buildings “within the river.”

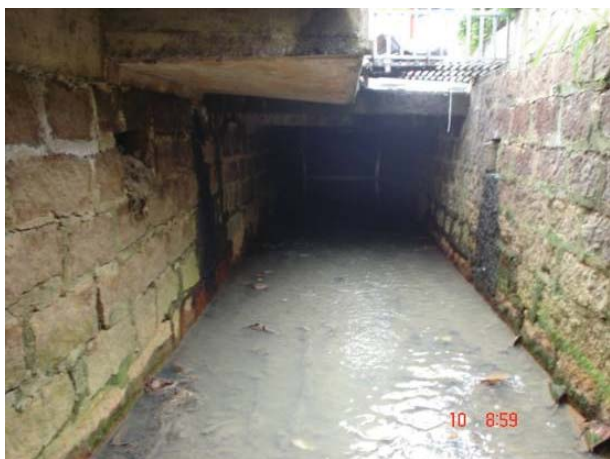
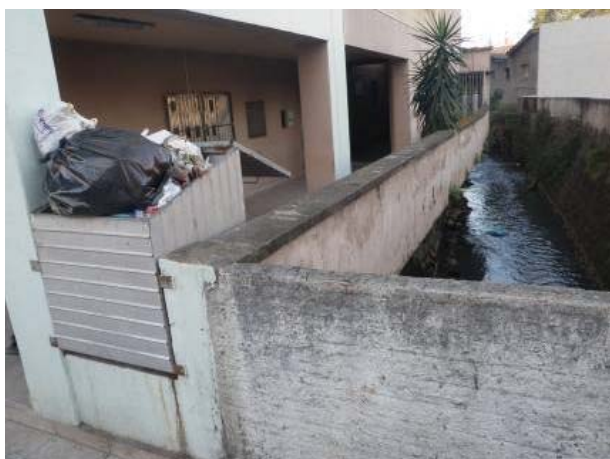
Fig. 5 - (a) Source: author photos.

river section (Figure 5 a and b). Advances of the buildings on the river Criciúma.

Spurred by this fact and aggravated by the lack of supervision and common sense, walls were erected on the line the shores, balconies on the river channel and a series of other irregularities that resulted in decreased

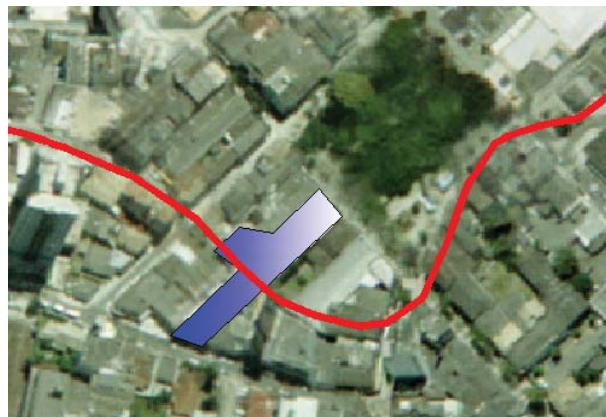
Fig. 6 - Building the mall on the river Criciúma

As an example we can cite the case of a Shopping Center, located in the central city. In this case, the edifice built not only affects the margins, but also built on the river's flow, making your stroke and the discharge of water occurs in a completely confined below the ground

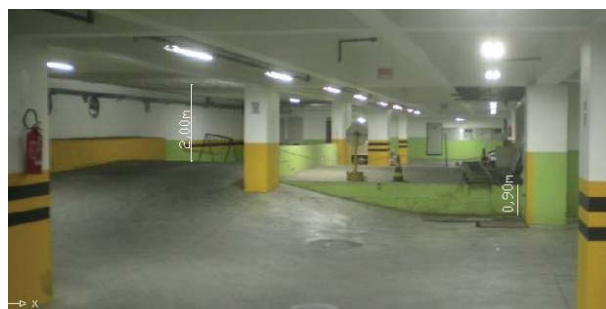
Fig. 7 - garage of the mall with the crossing over the Criciúma river.

(Fig. 7). This building has their garages with a floor level below the banks of the watercourse (approximately 90 cm) and, as a result, it was necessary to build ramps for vehicle passes from one side to another river.

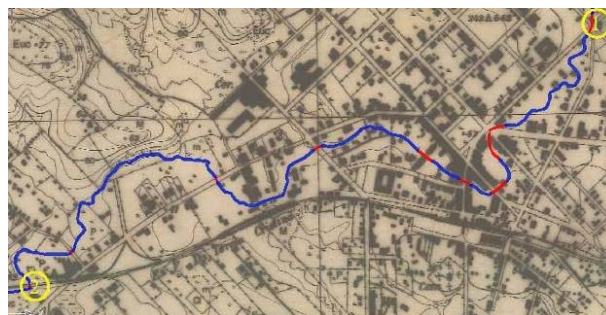
Fig. 8 - Stroke of the river in the city center on the base map, 1957.

The urban population density and pressure contributed to a significant alteration of the landscape over the years by replacing the natural riverbed Criciúma, on concrete slabs and buildings (Fig 8 and 9).

The analysis of the geographical map of 1957 with the overlay of the river and its layout Criciúma still unique among the sites 1 and 2 permits evaluation of the extent of urbanization and quantification of sections already allocated. In 1957, the section between points 1 and 2, average 2,550 m, and of this total only 409 m were channeled, ie, representing 16.04% of its total. Of this total pipeline, 240 m were located within 169 m of private property and in public areas such as culverts or bridges.

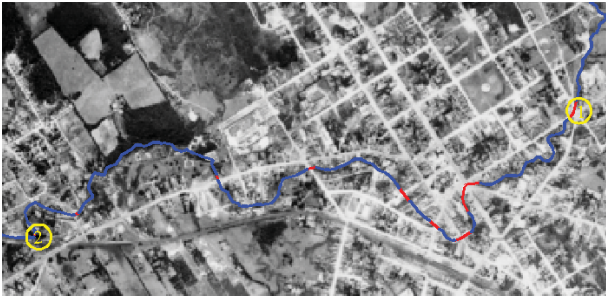
Fig. 9 - Stroke of the river in the city center on the Air 1957.

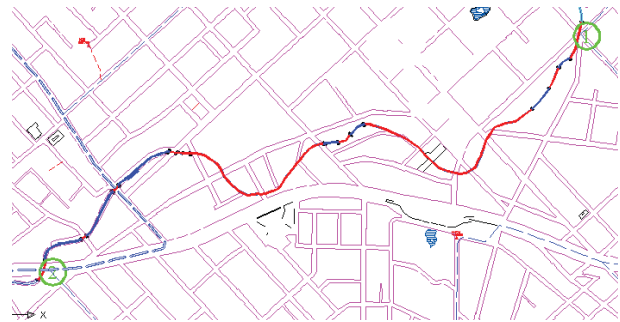
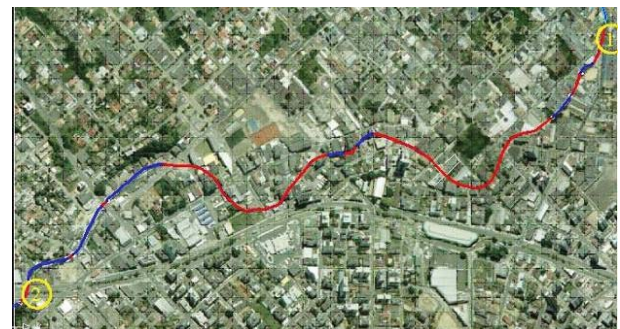
Fig. 10 a: Criciúma River on basemap 2001

Fig. 10 b: Criciúma River in air photo of 2006

The same analysis was performed using the base map, 2009. It was noted here that there was a reduction of 384 m in length of the section between points 1 and 2, resulting in a total length of 2,166 m for the stretch between these two points. In contrast stretches channeled 362% increase, totaling 1,480 m channeled (Fig. 10 a and b). This increase can be channeled

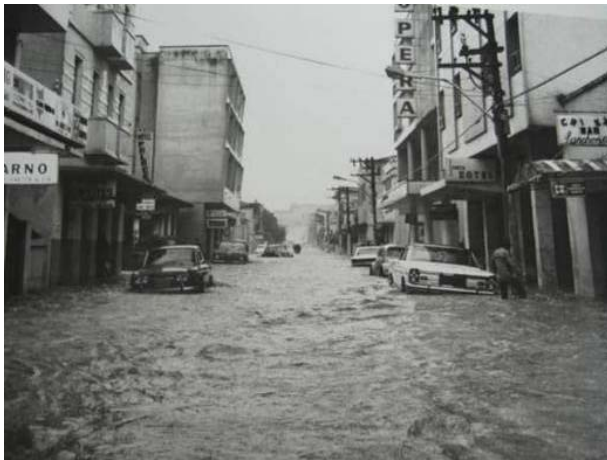
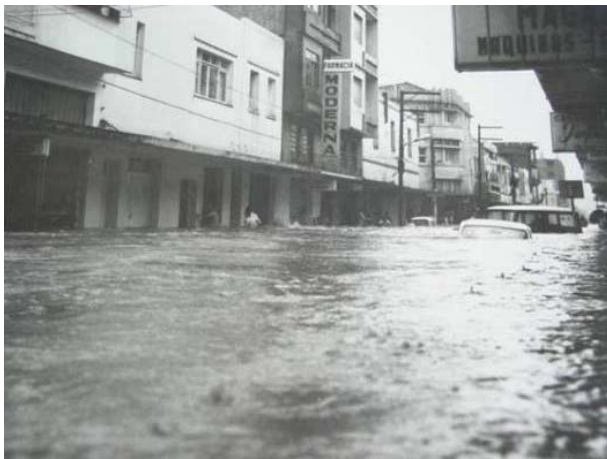
Fig. 11 a: Street Pedro Benedet in 1974

Fig. 11 b - Street on Janeiro 6 in 1974

In 1974 occurred the greatest flood recorded in the southern state of Santa Catarina, as the city of Tubarão most affected by the overflow of river shark. That same year the city center of Criciúma was completely flooded (Figure 11a and b), the consequence of a period of long rains occurred throughout the state of Santa Catarina.

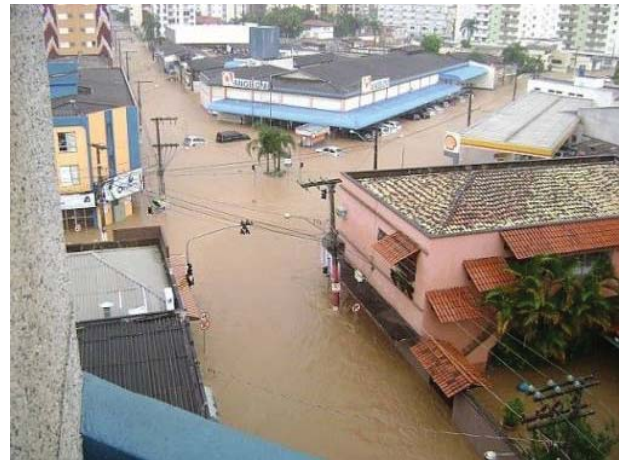
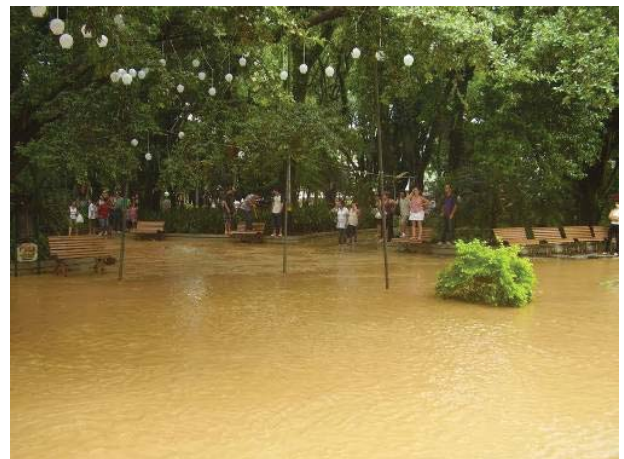
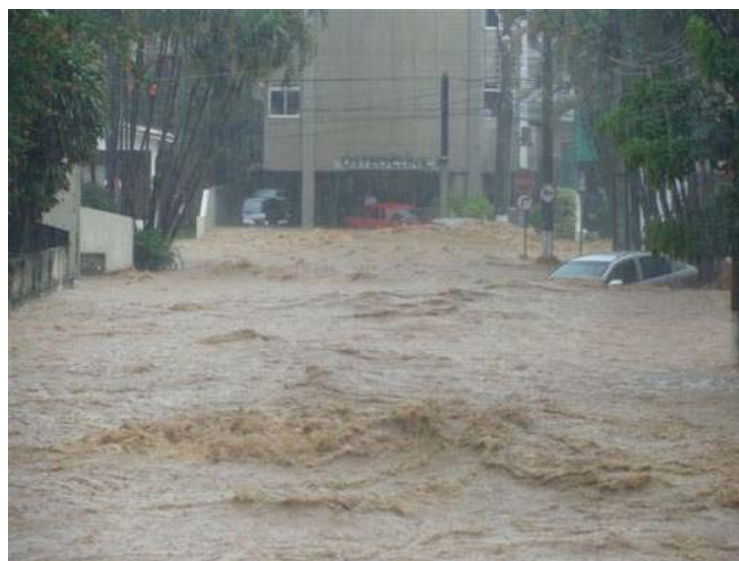
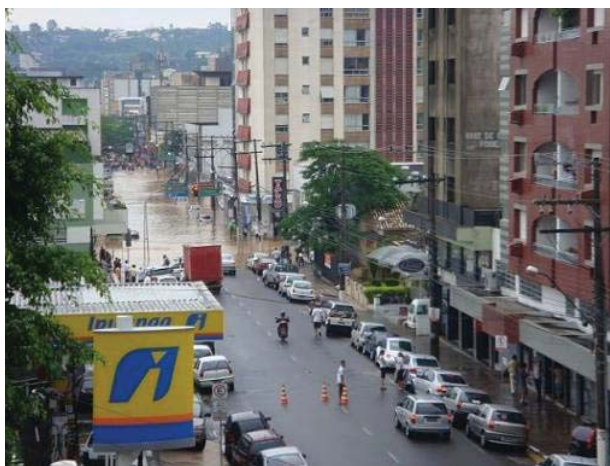
Fig. 12 a – Street Pedro Benedet.

Fig. 12b - Square Nereu Ramos

Fig. 12c – Street João Cechinel.

Fig. 12d – City Center.

The amplitude and frequency of flood events intensified after 2004 (figure 12 a, b, and c)

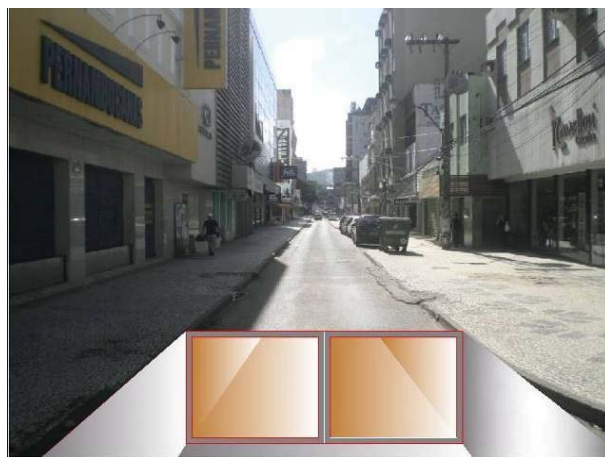
Fig. 14 - Schematic isometric galleries for the auxiliary channel to the Criciúma River.

The auxiliary channel to the river Criciúma, will run under the central streets, as shown in the isometric diagram shown in Figure 14.

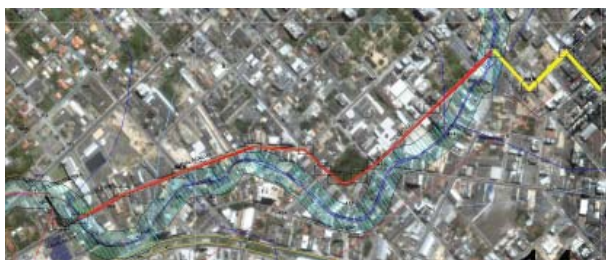
The proposed path has three segments with different discharge capacities: a) section 1 (yellow) - discharge capacity of 22.26 m³ / s b) section 2 (red) - discharge capacity of 33.70 m³/sec section 3 (black) - discharge capacity of 45 m³ / s. The download of this channel will be in the river overflow river itself Criciúma a point where the pipeline sequence will occur only at intersections with streets. Services and works will be needed in order to facilitate the discharge of the river downstream, stand out among them is the replacement of 04 bridges, with an increase in cross section, and dredging of the river. (Fig. 13).

Fig. 13 - Route help channel the river Criciúma.
