LAND REHABILITATION WITH THE USE OF BIOLOGICAL GEOTEXTILES, IN TWO DIFFERENT COUNTRIES

Reabilitação de Solos com Uso de Geotêxteis Biodegradáveis em dois Países

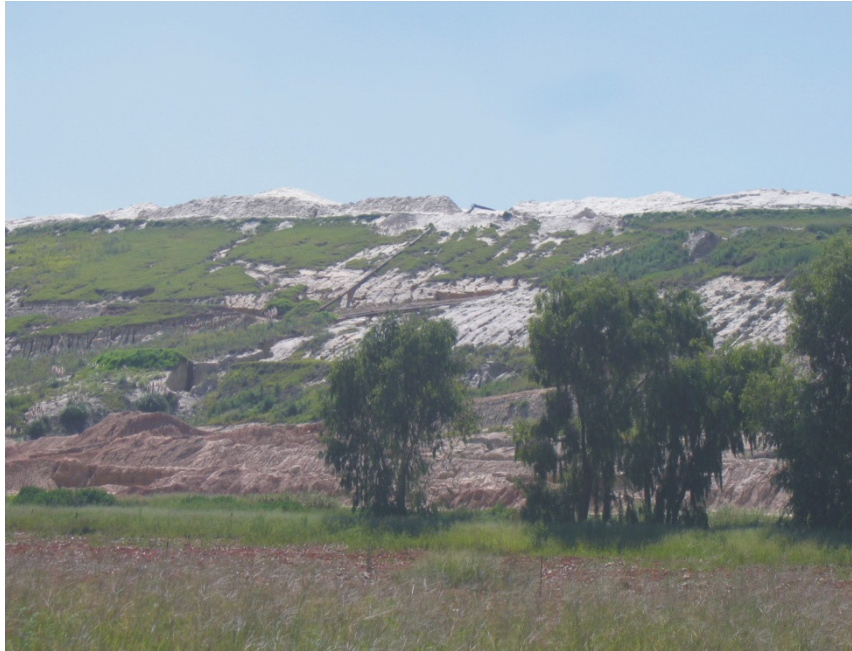
Figure 2: 'Mega-dump' of reprocessed gold tailings, south-east of Springs, Gauteng Province. Heavy rains in February 2008 led to landslides that denuded large parts of the previously vegetated slope.

Krugersdorp in the west part of Johannesburg and Soweto to Boksburg in the east and on to Springs (Figure 2). This waste belt is situated in a densely populated urban area.

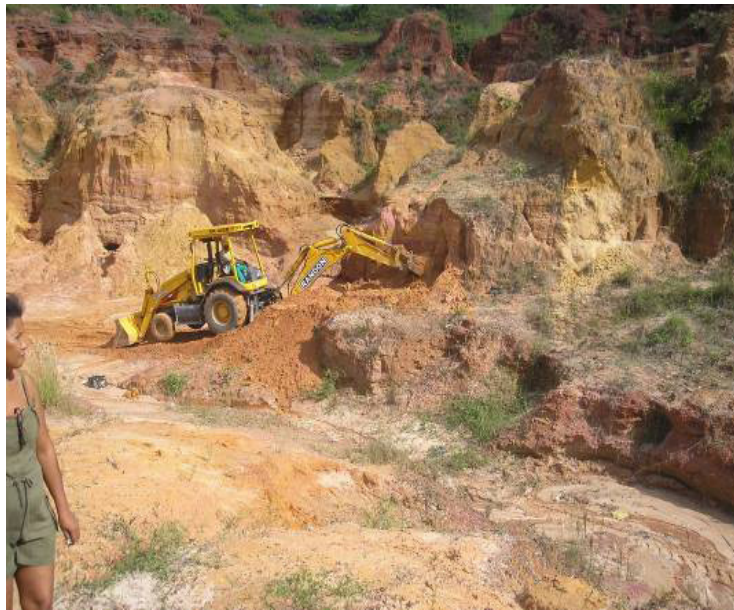
Figure 5: Initial work in areas 4-8. Source: LAGESOLOS, 2008.

caesalpiniae folia) was used on the higher parts of the gully, to protect the topsoil. The rehabilitated area was fertilized with 500 kg ha⁻¹ of NPK (4-14-8) and decomposing palm was added to topsoil, as a source of organic matter. The project employed 10 local men for six days, who conducted the work using hand-held tools (Figure 4). A tractor (type backhoe loader) was used for two days to construct the terraces (Figure 5).

The rehabilitation work in Sacavém was divided into three areas, presented in Figures 4 and 5, because of local relief characteristics. Areas 1-3 (Figure 6) were constructed with men and tractors; areas 4-8 (Figure 6) were made in the higher parts with a tractor; and areas E, M and D (Figure 3) were reshaped exclusively by manual labour.

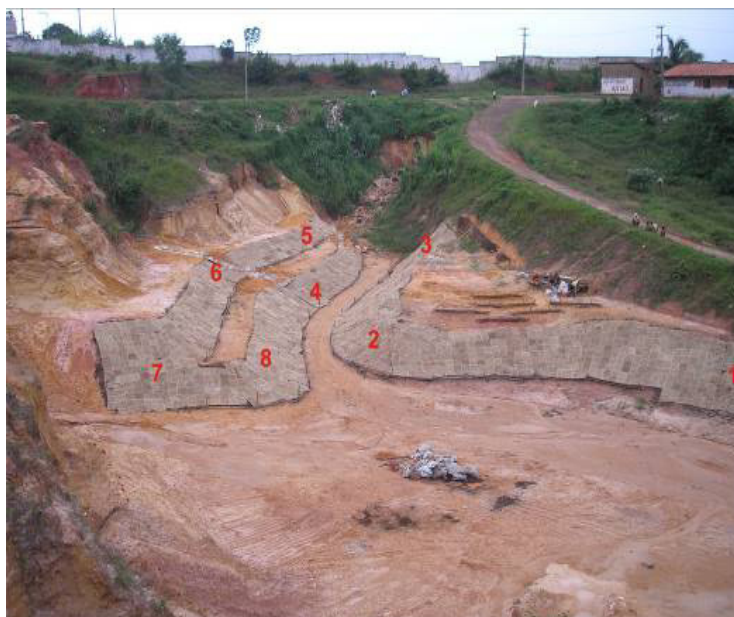
Figure 6: Rehabilitated areas with cover of buriti geotextiles, Sacavém Community, São Luís, Brazil (Areas 1-3 were constructed with men and tractors; areas 4-8 were made in the higher parts with a tractor). Source: LAGESOLOS, 2008.

In Part 1 (Figure 6: areas 1-3) the team used biological geotextiles and organic matter from decomposing palms, seeds and inserted barriers of wooden stakes along contour lines. This area had formed due the concentration of runoff from the street above the gully (Figure 7).

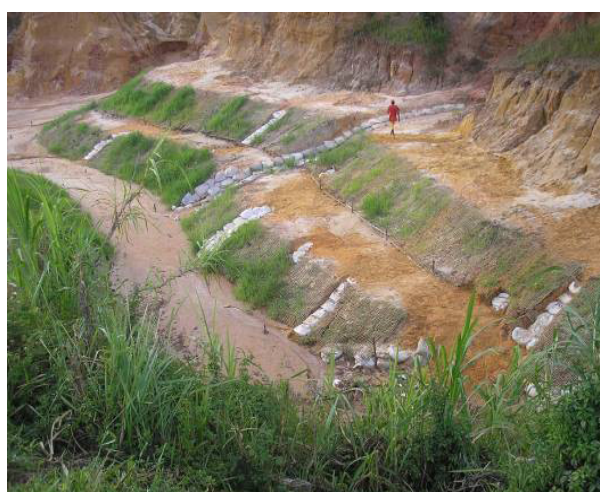
Figure 10: Maintenance work at the rehabilitated area one month after rehabilitation, Sacavém community, São Luís, Brazil. Source: LAGESOLOS, 2008.V

For one month after the rehabilitation work São Luís City experienced intense and prolonged rains (Table 4), which presented attendant problems for the rehabilitation work. However, we again employed local people to work on site maintenance (Figure
