AN EROSION PROCESS STUDY AND THE APLICATION OF THE DEVICES TO MONITORING IT: a case study in Ipameri – GO – Brazil

Érica Aparecida Vaz Rocha¹ – ericaavr@ibest.com.br – UFU

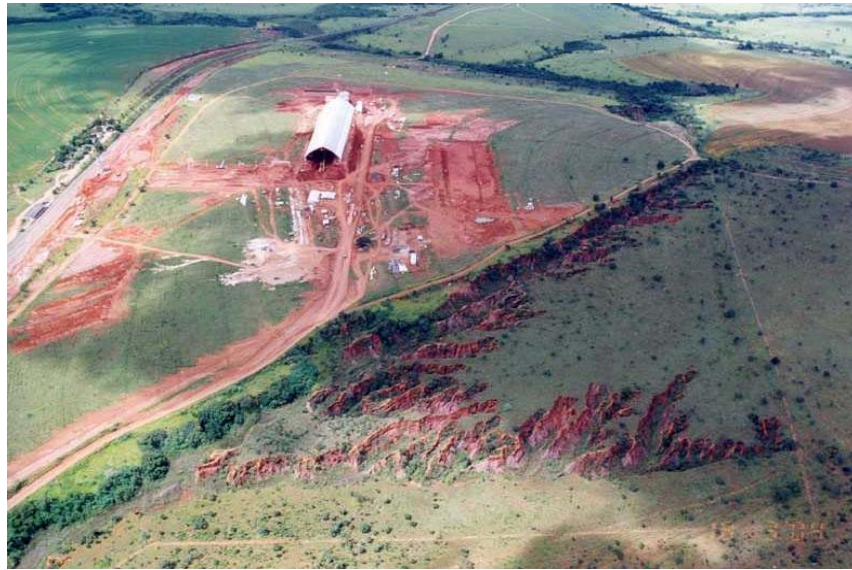
Fig.1 – In this picture it is possible to see the erosion process where this paper have being developed. Also, it is possible to make a comparison between the size of the facture (at the bottom of the picture) and the gully studied located at the front of the picture (ROCHA, Erica – 2004).

The present paper intends to develop a research in a gully (linear erosion) (fig. 1), a fact that worries all, specially that people who are directly related to an erosion process, having problems as roads and houses destruction, loss of the fertile soil, possibility of damage to the factories areas, etc.

The studied gully is located in a rural area. This kind of big gully is very common in the region, and in this case, the gully is approximately 15m depth, reaching the sub-superficial watery, 1040m length and 40m width. However, this research have being done just at a sub-channel (fig. 2), which holds less measurements than the mainly channel (it is shorter). This study place had been chosen because it had presented a lot of characteristics related to the high activity of the erosion process. So, it was started a collection of sediments for making quantitative and qualitative analyses, a measurement of the gully's edge advance, picture comparison, and with this, the evolution of the channel would be evaluated along to the time.

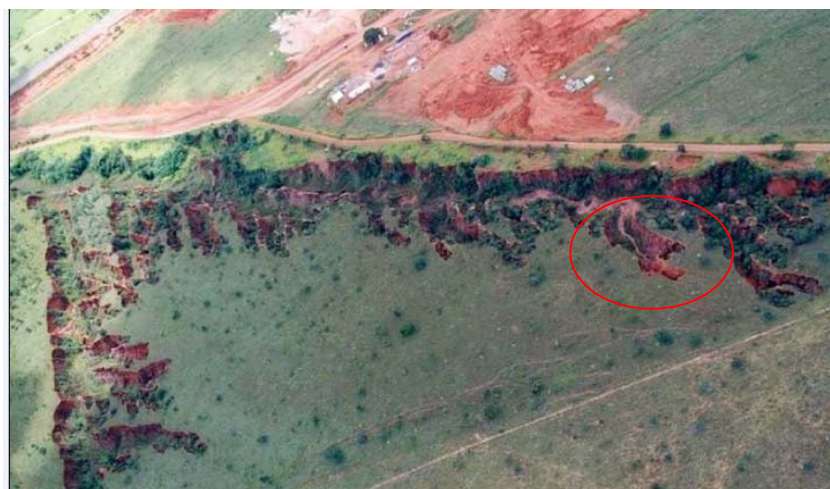
Fig.2 – Picture from the studied area. The area is detached with a red circle (ROCHA, Erica – 2004).

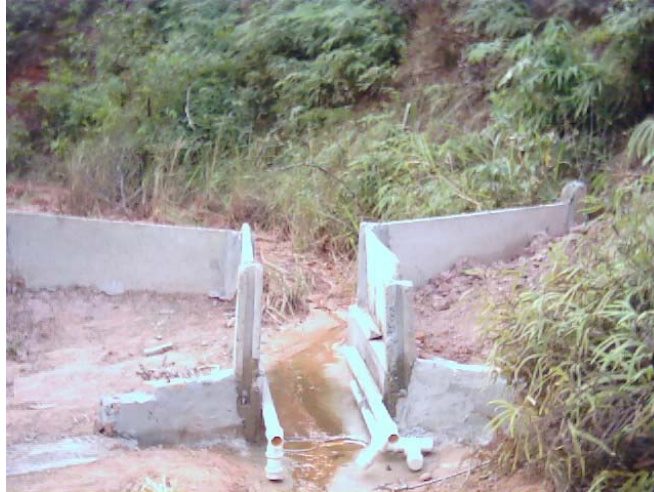
Fig. 3 – This picture shows an embankment with a floodgate that was installed into the gully channel for collecting data about sediments transported at the bottom (ROCHA, Erica – 2004)

For reaching the objectives of the research, an embankment with a floodgate was installed into the secondary gully channel (research area) (fig. 3). With this device, it was possible to collect data about the quantity of the sediments transported at the bottom of the channel. For this, a sediment trap has being used in each 7 days, and after the sediment collection, the sediment was transported to the lab where it has to pass through a dry process, and after that, the quantity and quality analyses were done using some lab devices and tools.
