EROSIVE PROCESSES IN URBAN AREAS IN THE ISLAND OF MARANHÃO – BRAZIL

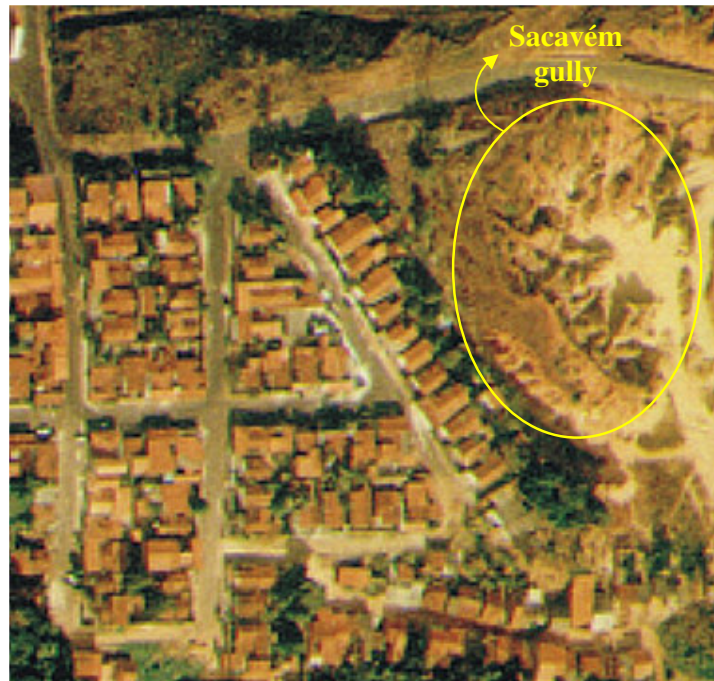
Figure 2: Aerial view of the Sacavém gully: Note proximity to the houses (at left), which unevenness with the gully's basis is four meters approximately.
(Source: Embrapa, 1999, scale: 1:4.000; extracted of: Bezerra, 2003, modified)

According to Mendonça (2003), the erosive processes in Maranhão are very severe, and deforestation is one of the main causes in areas of accelerated urban expansion. In the municipal district of São Luís and surroundings, several places are found with erosive features in large scale. In some cases, the houses and people's lives are at risk (Figures 2 and 3).

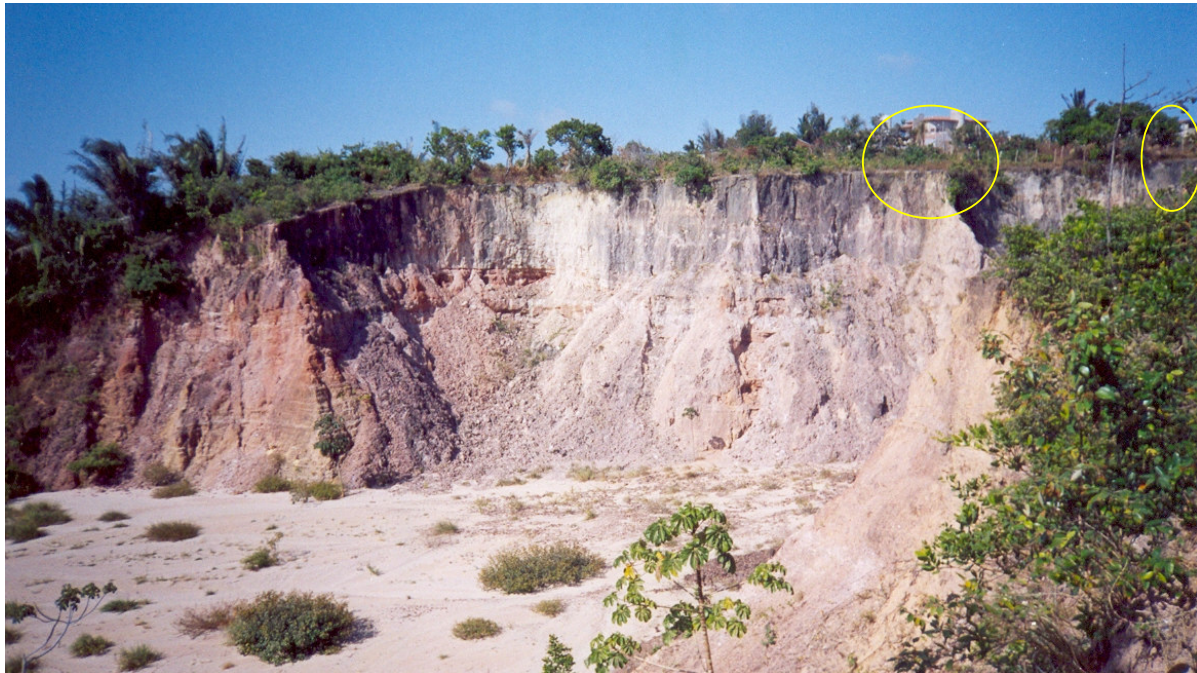
Figure 3: Paço do Lumiar city's gully: Note the presence of houses at the top of the photo, threatened by the progress of the gully (Photo: Sathler, 2004)

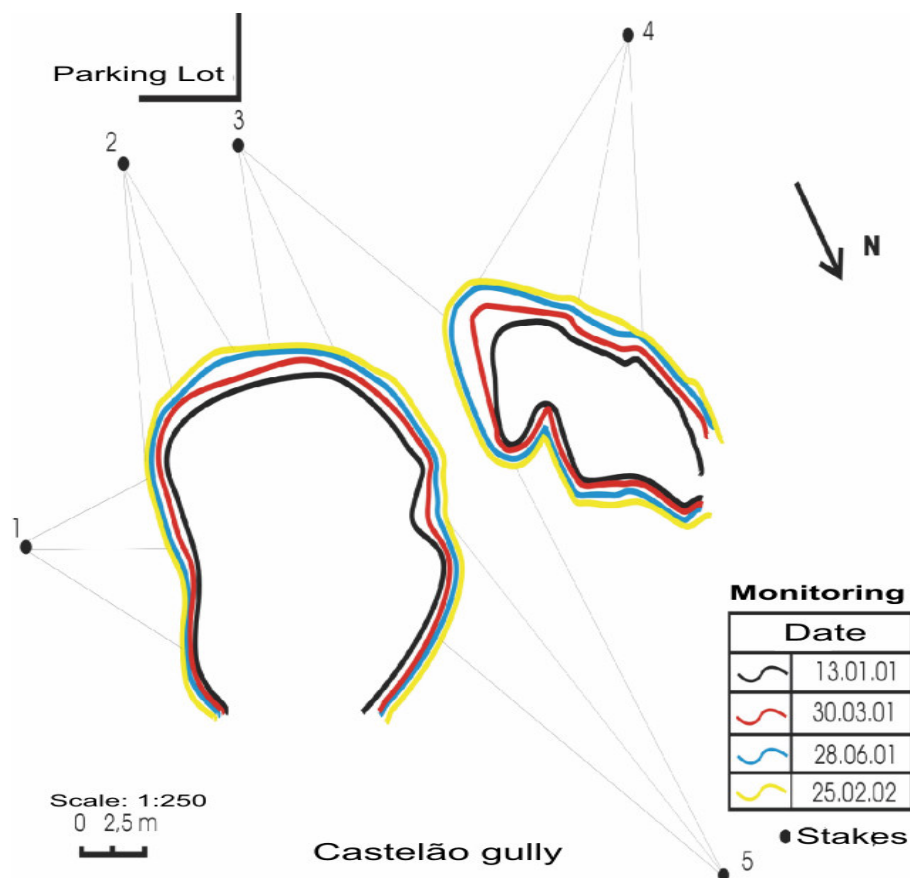
Figure 4: Diagram of Castelão's gully monitoring (Mendonça, 2003).

Two initially identified gullies of Castelão and Sacavém (Figure 1) have been monitored by photo-interpretation and stakes, according to the described method by Guerra (1996). Stakes are fixed around of gullies; a Brunton compass and a meter are used to obtain three measurements taken from each stake to the gully border. Through this monitoring procedure, it is possible to determine the speed and the direction towards which the gully is retreating. Tables and diagrams are done, and demonstrate the advance of the erosion in these areas, as figures 4 and 5 demonstrate.

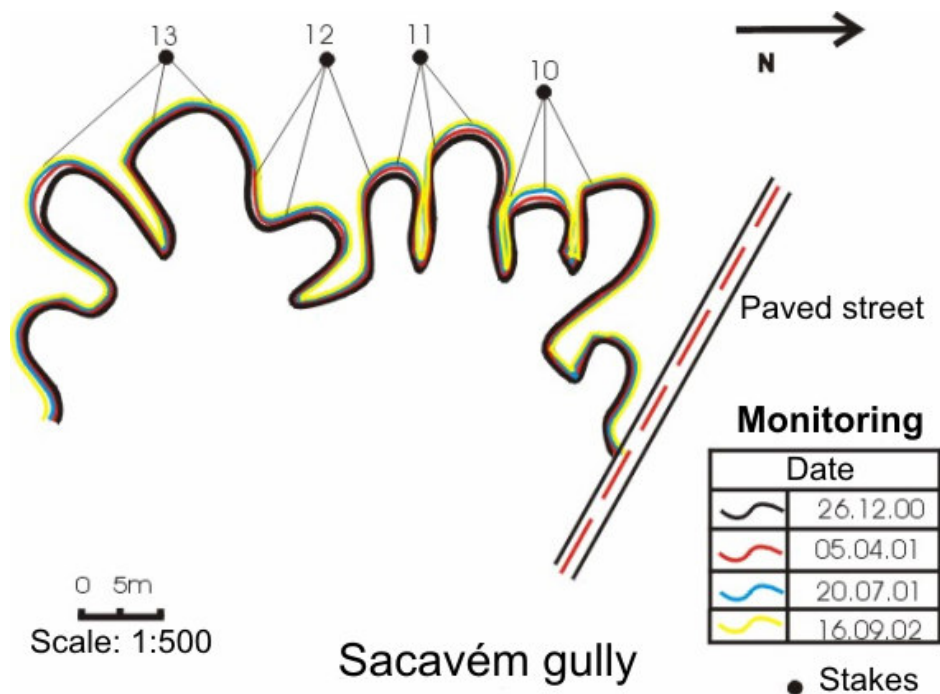
Figure 5: Diagram of Sacavém's gully monitoring (Mendonça, 2003).
