ENVIRONMENTAL PROBLEMS AT THE AREA OF MUNIM RIVER DRAINAGE BASIN AT THE TOWN OF CHAPADINHA – MA

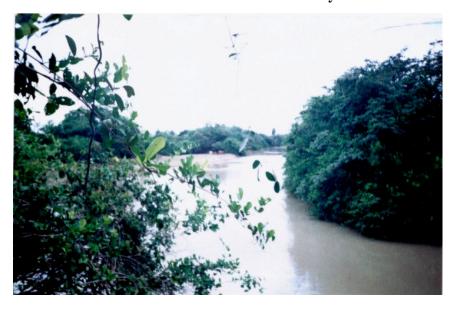
The Munin river basin receives water from different tributaries, like: *Preto* River and *Iguará*, keeping a minimum outflow that avoid their disappearance during dry weather. It has stretches of preserved ciliary wood that retard the occurrence of erosive processes. (Pic. 02)

Picture 02- Preserved ciliary wood area

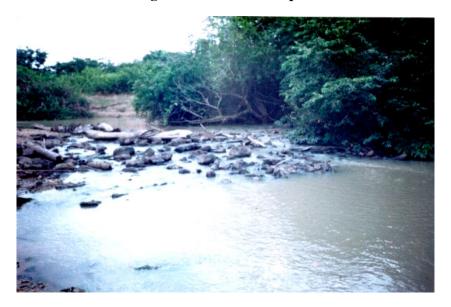
The Munin River Basin is framed in the type of *exorreica* drainage, because its water flows to the sea, taking with itself intemperate materials from elevated areas from its spring to the coast, modeling the land alongside its way. (Pic.03)

Figura 03- Stretch of rapids

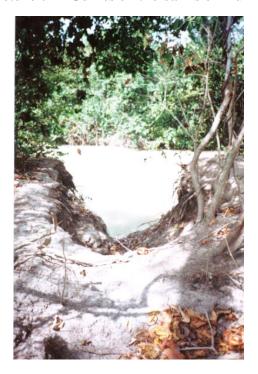
Nowadays, it is possible to know through several studies performed in the nature that the erosive processes depend on countless factors that control their acting, they are: the erosive aspect of the rain, ground properties, vegetal cover, characteristics of the slopes and others (GUERRA, 1994). Among the problems caused by erosive processes, the erosion of watercourse bank stands out, the silting of the river and the presence of the erosive feature (ravines and gullies), and others (Pic. 04)

Picture 04 – Gullies on the banks of Munim

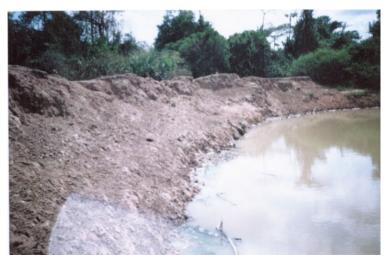
The Basin of the Munim River in the stretch of Chapadinha show some problems caused by human action. Among them the more perceptible is the erosion and consquently the silting of the river (Fig.05)

Picture 05 – Erosion on the riverbanks

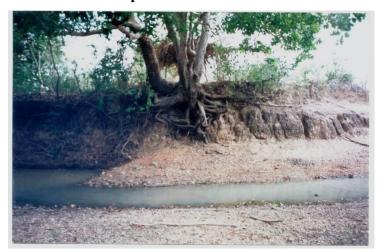
For Cunha (2003) "the enlargement of the channel are caused because of the erosion and ruined riverbanks; exposed roots; bent and malformed trees and growing into the channel (Pic.06).

Picture 06- Exposed root trees on the bankriver

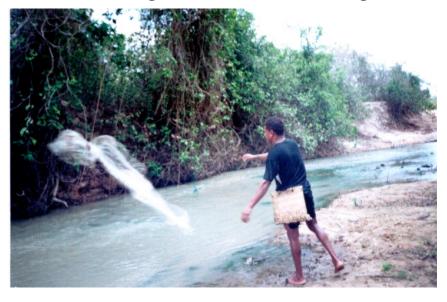
Figura 06-Riverrain resident fishing

Most of residents of the villages near the bedriver take from it the necessary resources for their survival. Among the uses of the river stand out fishery, removal of gravel and sand, bathing, washing clothes and leisure time. During the interview with some local residents it was mentionated the problem of reduction of fish, due to the technique named *moita*, practiced alongside the river. The *moita* consists of cutting down the ciliary wood to produce an artificial environment for the spawing, after some week fishnet is put around that environment to catch the fish (Pic.06)
