THE USE OF DIGITAL PHOTOGRAPHS TO QUANTIFY VEGETATION GROUND COVER IN DEGRADED AREAS

ABSTRACT

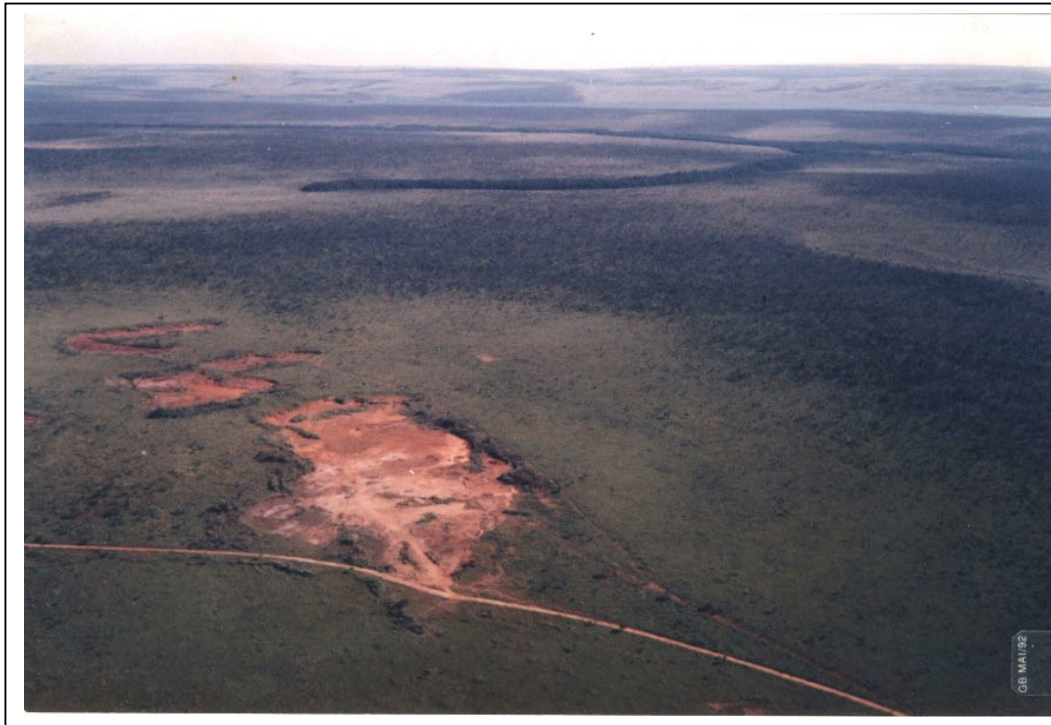
Figure 1: Aerial view of the gravel pit where an experiment aimed at developing methodology to reclaim mined land with savannah species were implemented in 1992. The area is located in the National Park of Brasília, Federal District of Brazil

The site studied is located at the National Park of Brasilia, Federal District, Brazil, and covers an area of approximately 6 hectares (Figure 1). Gravel was extracted from the area in the early 60's. The original savannah vegetation of the site was removed and the mineral was extracted up to a 2 meters depth. Nothing was done for almost 30 years to reclaim the mined area. As a consequence, the surface of the gravel pit remained bared, without vegetation cover.

For results from research conducted in the experimental site Figure 1, published since 1992, see Leite et al (1992), Martins (1996), Leite et al. (1994), Baptista & Leite (1997), Martins et al. (2001).

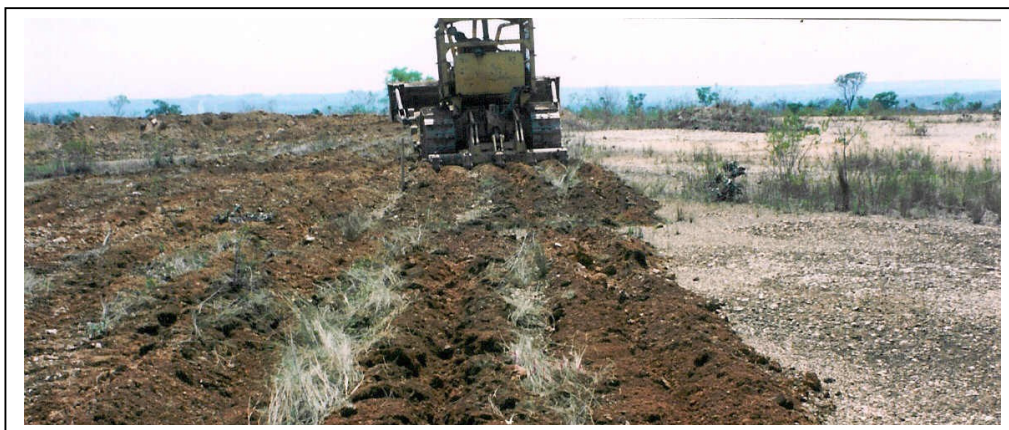
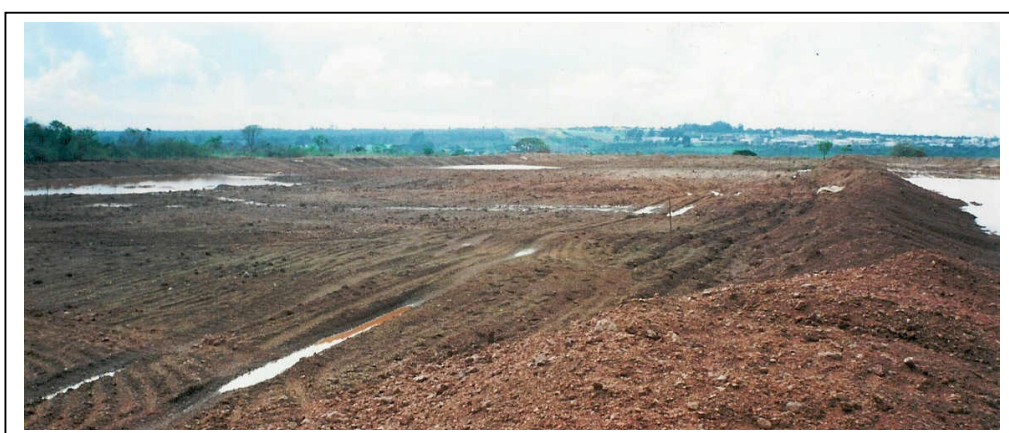
Figure 2: Details of the substrate preparation (A and B) and the experimental design (C) employed in the original research, which was established in 1992

In 1992, as part of a research project supported by the Brazilian Institute for Environment and Natural Renewable Resources (IBAMA), conducted by members of the research staff of the Ecology Department of the University of Brasilia, soil conservation measures, including terracing, subsoiling and manuring were realized in the area (Figures 2 a,b). Experimental design of the 1992 research, including size of plots, treatments and replications is illustrated in Figure 2c.

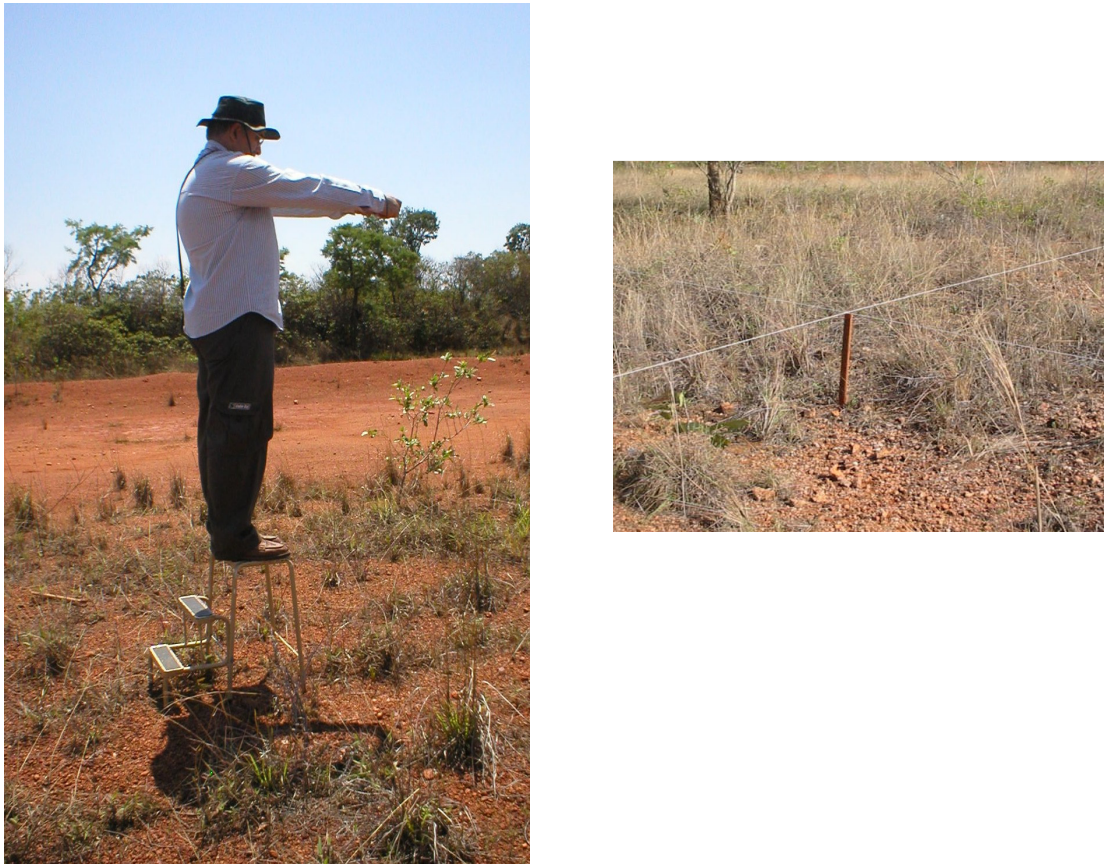
Figure 3: Photographer taking pictures from approximately 2.10 meters high with a digital camera and, on the right, details of the demarcation of the centre of each experimental plot

A portable Canon camera (model Power Shot A 100) was used to take digital photographs of the experimental site. Photographs from approximately a 2,10 meters high, perpendicular to the ground, were taken of the centre the 24 experimental plots on the 11th of October of 2003, in a sunny day (without clouds), from 10 to 12 am. The same photographer took all the 24 photographs used to assess the vegetation ground cover (Figure 3).
