## CASE REPORT

# USE OF PROSTHESIS IN A CAPARACE FRACTURE OF *Chelonoidis carbonarius* (Testudines: Testudinidae)

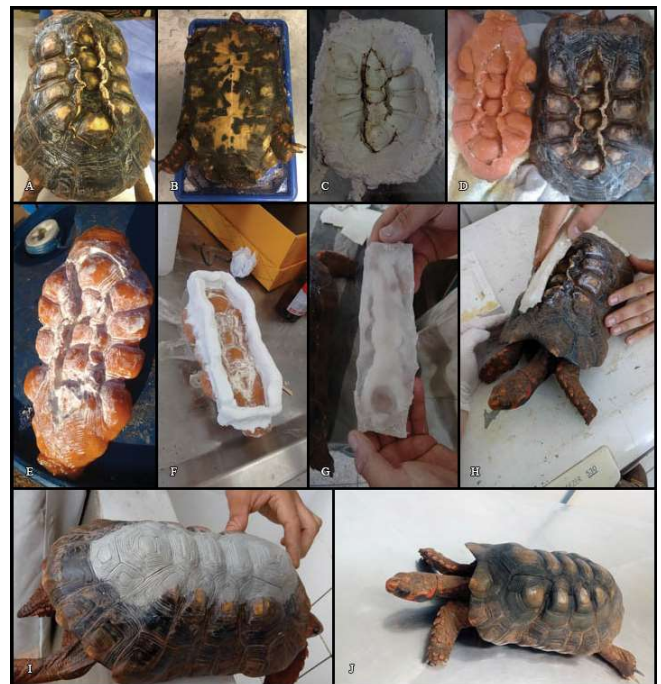
**FIGURE 1** - Stages of the carapace prosthesis production for a *Chelonoidis carbonarius*. A: Fracture consolidated in vertebral shields of the carapace. B: Positioning of the specimen for the impression of the fracture in an orthodontic mass; C: First alginate mold. D and E: Acrylic resin mold mimicking the fracture. F: Second mold for making the acrylic resin prosthesis. G: Acrylic resin prosthesis. H: Prosthesis test on the tortoise for molding. I: Finished prosthesis and fixed to the carapace with epoxy putty. J: Final appearance of the prosthesis after painting with gouache paint.

In 2018, with the aim of improving the quality of life of the specimen, it was decided to manufacture a synthetic prosthesis. Initially, a mold of the deformation of the carapace was made with alginate<sup>4</sup>. Then, acrylic resin<sup>5</sup> was used to produce a second mold, similar to the carapace failure, so that the prosthesis was sculpted without compromising the animal. The area of the lesion mimicked in the acrylic resin mold was isolated with varnish and filled with acrylic resin, so that a cover was formed to be fitted to the animal's deformation. Subsequently, the prosthesis was finished with

the aid of a micro grinder, fixed with two-component epoxy<sup>6</sup> putty and painted with gouache paint<sup>7</sup> (Figure 1).
