Risk Mapping Associated With Mass Movements in Viçosa
(MG) Urban Area

Master Leandro Antônio Roque

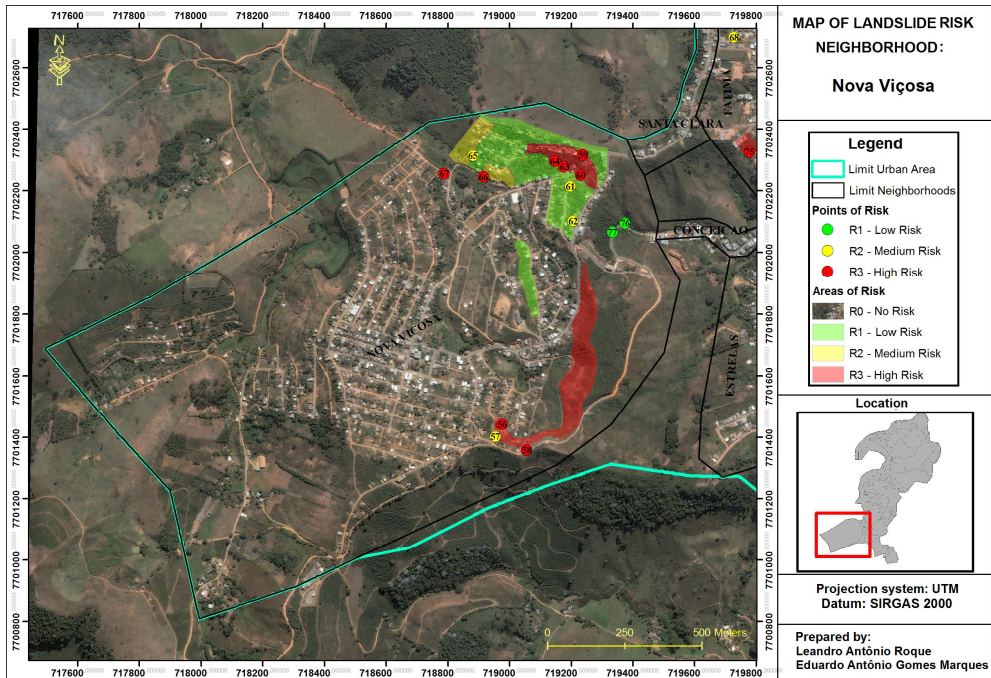
Figure 5: Landslide risk map of Nova Viçosa district.

On medium risk areas and on places located at points number 57, 61, 62 and 65, the main risk factors identified were modification of natural drainage conditions (cuts and embankments) and damages caused on the artificial drainage system, which was also undersized, but factors such as slope, presence of trash and debris on face/top of the slope, has also contributed to geological-

geotechnical risk classification. It should be noted that if both preventive and corrective actions are not deployed on these areas they may have its risk rating elevated to high.

Points 76 and 77 and low-risk areas mapped in this sector are places where landslide trigger agents exert low influence. Although, occupation of these areas should be planned in such a way that the risk of mass movements in these areas would not be increased by disorderly occupation.

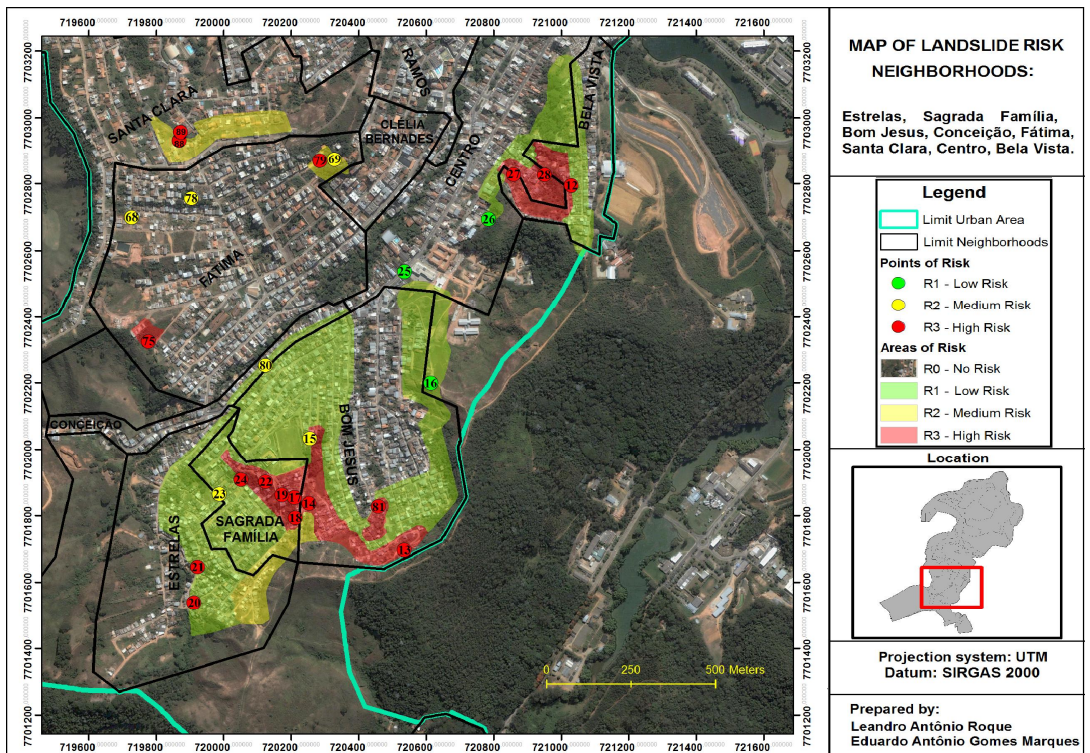
Figure 1: Landslide risk map of Estrelas, Sagrada Família, Bom Jesus, Conceição, Fátima, Santa Clara, Centro and Bela Vista districts.

These neighborhoods, represented on Figure 6, highlight the vast, high-risk area located between the neighborhoods Estrelas and Bom Jesus, in which were identified several high-risk points (points number 13, 14, 17, 18, 19, 22, 24 and 81). The slope is greater than 35%, with the presence of low constructive pattern residences and several inadequate cuts and landfills.

High-risk points (20, 21, 27, 28, 75, 79, 88, and 89) are points that exhibit slopes with high height and declivity, in which there have been landslides. For the high risk point, number 12 – Bela Vista district, the highest risk factor is related to a terrain located at the top of hill with slope greater than 40%, which is used as a irregular dump site by the community. The debris located on this site, associated with the slope of the hill, endangers the population of Rua São José, located on the bottom of the tank.

Medium risk points (15, 23, 68, 69, 78, 80) are located in locations of higher declivity, with both natural and artificial drainage systems damaged. Recovering of these drainage systems is necessary to prevent landslides.

In low-risk points (16, 25 and 26) there were signs of erosion due to damage of the natural drainage systems and the absence of an artificial drainage one.

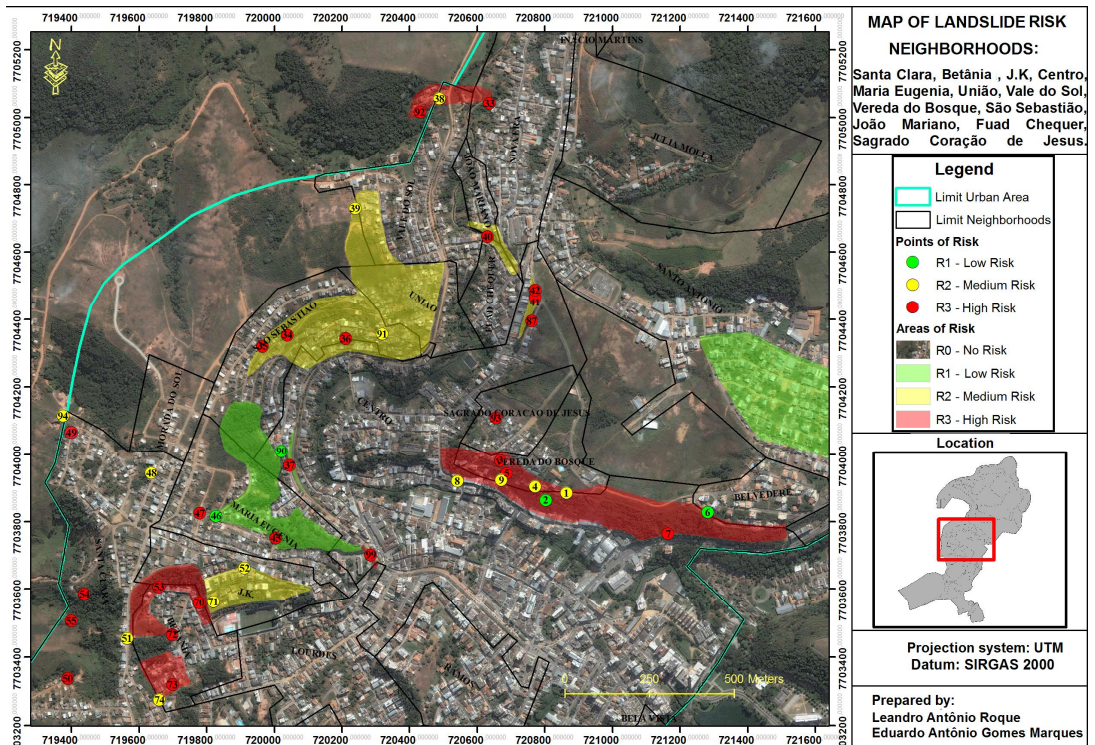
Figure 8: Landslide risk map of Santa Clara, Betânia, J.K, Centro, Maria Eugenia, União, Vale do Sol, Vereda do Bosque, São Sebastião, João Mariano, Fuad Chequer and Sagrado Coração de districts .

This set of neighborhoods represented in Figure 8 concentrates the largest number of risk points registered in the present study. From a total of 42 points of risk, 25 points were classified as high risk, 13 points were classified as medium risk and 4 points were classified as low-risk.

High-risk points number 3 and 5 presents scars of landslides occurred in January 2012, mainly due to the high slope of the terrain - more than 45%, to poor drainage and to buildings constructed to close to slope top. At point number 5 it is also observed, in addition to these factors, the presence of rubble that is played indiscriminately at the top of the slope. At points 7, 37 and 45 the high risk is mainly caused by deficiency in natural drainage and damage of artificial drainage system. In point 45 the lack of drainage is also responsible by erosion processes verified in this local.

The lack of drainage and paving of streets that are located at the top of the slope are common risk-generating situations observed in points 34, 47 and 53, while the high level of risk observed in paragraphs 35 and 93 is due to the presence of large amount of trash and debris.

Slope cuts with high declivity and/or height are main factors responsible for high landslide risk situations observed at points 36, 40, 42, 50, 54, 55, 70, 72, 87 and 99. In point 55 did not yet exist on the date of completion of the image, the set of popular houses located at the base of the slope on point 87. In point 40, in addition to the high cut slope, there are some rock blocks in slope face that lies in the back of the gas station located at Rua dos Passos. As there is a dense bamboo vegetation on this site, a large amount of water is retained on this slope, which acts as extra weight, increasing the risk of sliding.

High-risk areas delimited on these neighborhoods are locations in which the occupation must be avoided, and all existing buildings should promote measures to decrease the risk of landsliding, mainly those focused on slope cuts and drainage channels. If these works are not installed, there is a need to interdict several dwellings. Figure 9 presents some of the risk situations found in these sets of neighborhoods and described above.

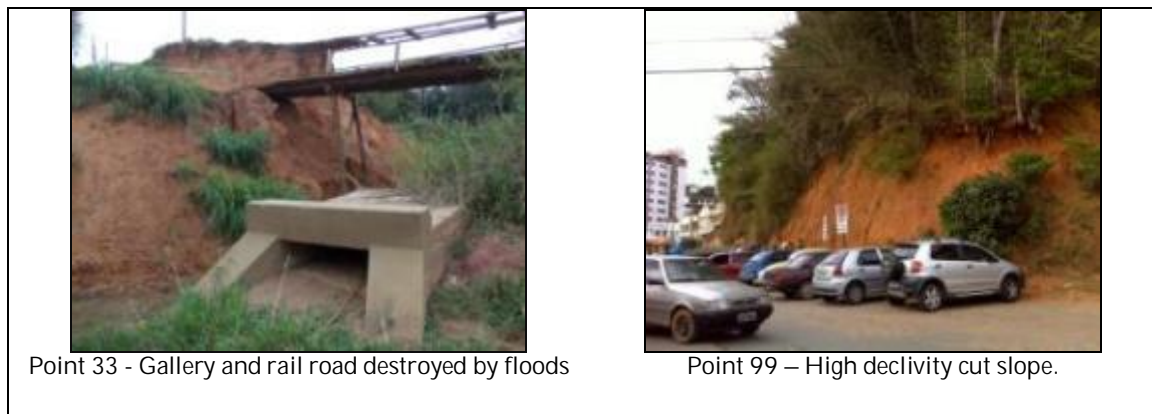
Point 92 - Subsidence caused by margin erosion, on a creek

Figure 9: Examples of some of the existing aspects in the risk areas of Santa Clara, Betânia, J.K, Centro, Maria Eugenia, União, Vale do Sol, Vereda do Bosque, São Sebastião, João Mariano, Fuad Chequer and Sagrado Coração de Jesus.
