EROSIVE PROCESSES AT BOMBOM HILL AREA, COROADINHO, SÃO LUÍS — MA- BRAZIL

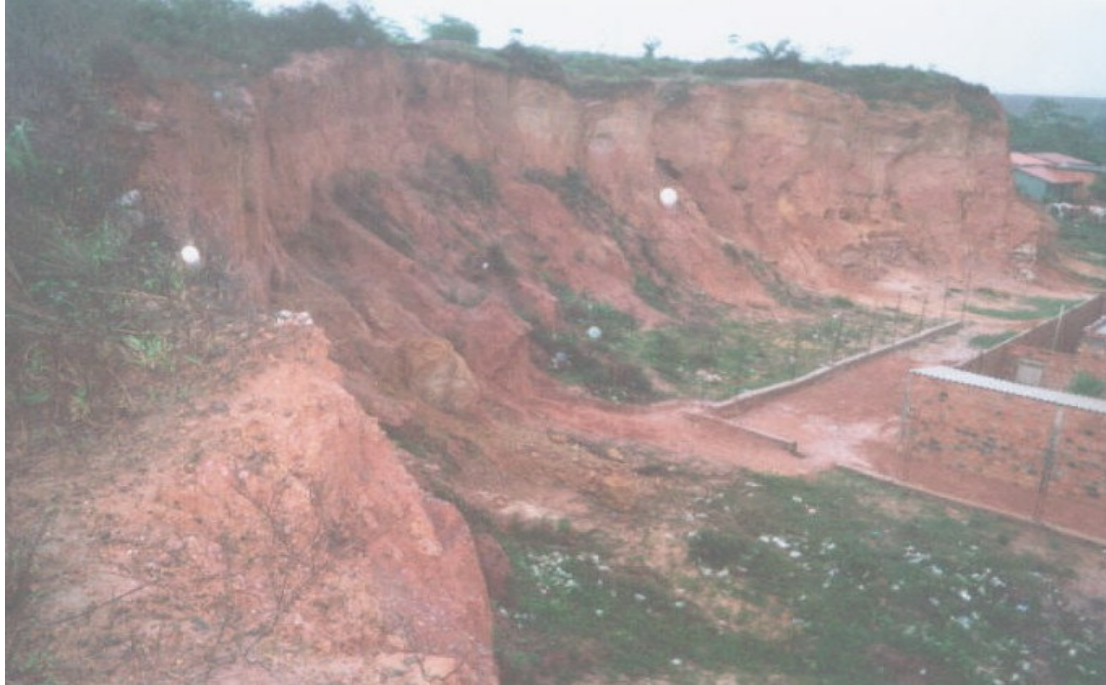
continues to build houses in erosion areas near the *Bombom*, about 3 meter from the Barrier (Picture 01).

Picture 01 Erosive processes

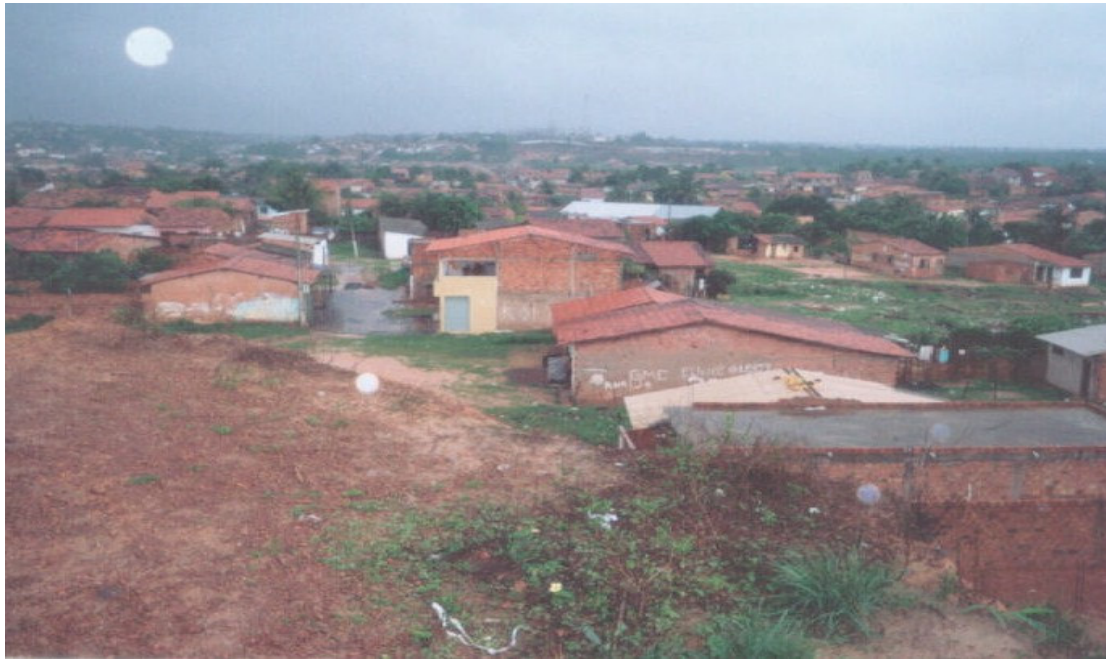
The area of *Bombom Hill* that is suffering process of the erosion like ravines and gullies, according to Mendonça (2003; p. 25). In the total area of the Hill, there is trailing or non-existent vegetation in some parts (Picture 02) and several places with deposit of wastes (Picture 3)

Picture 02 Non-existent vegetation

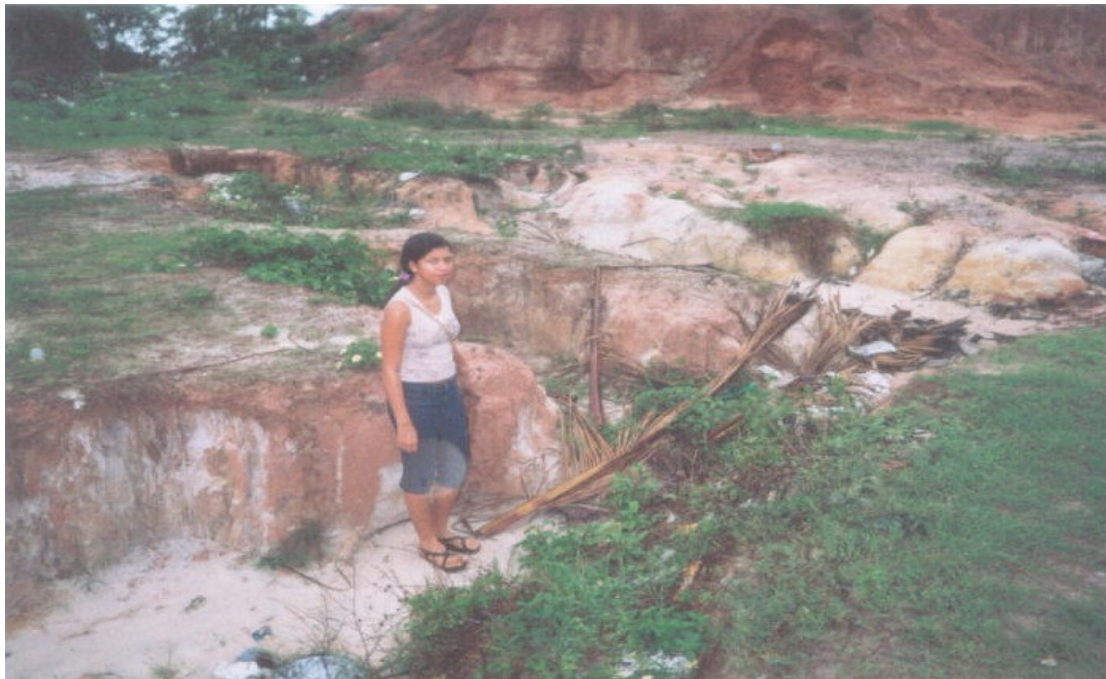
Picture 03 Deposite of waster
