SOIL EROSION ANALYSIS IN THE INFLUENCE AREA OF TIETÊ- PARANÁ HYDROWAY (TIETÊ BRANCH)

Instituto de Pesquisas Tecnológicas do Estado de São Paulo- IPT
(Technological Research Institute)

ABSTRACT

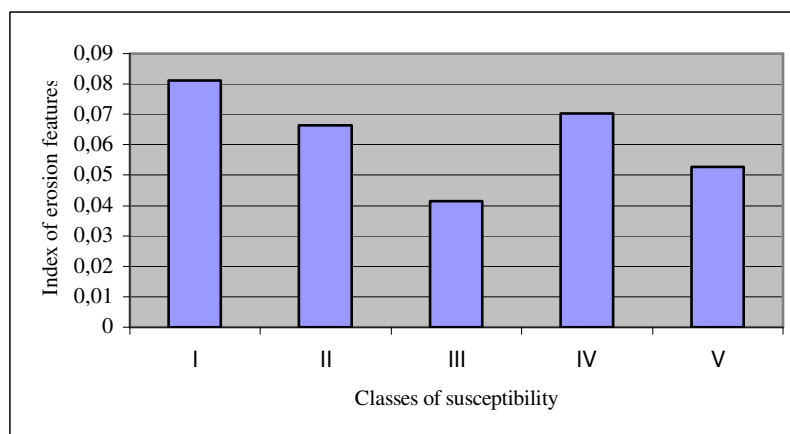
Graphic 1 – Index of erosion features by classes of susceptibility

The soils with sandy texture are more prone to erosion. Laminar erosion occurs intensively in any class of erosion susceptibility, while ravines and gullies are the main forms of erosion in the classes I, II and III, representing the most remarkable erosion processes (Table 1 and Graphic 1).

Classes of erosion susceptibility	Number of erosion features	Area (km ²)	Index of erosion features
I	1019	24.829,13	0,0812
II	245	14.272,56	0,0664
III	343	17.434,29	0,0415
IV	262	13.426,31	0,0702
V	14	1.117,86	0,0527

Table 1 – Distribution of erosion features by classes of susceptibility

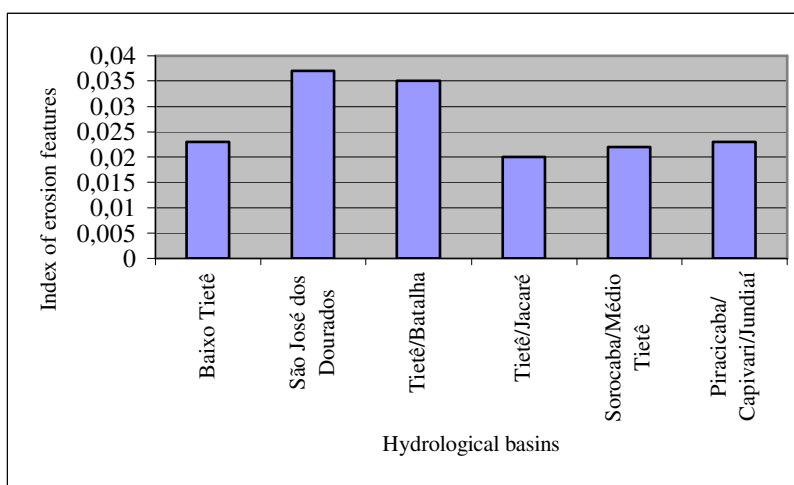
Graphic 2 Number of erosion features by hydrological basin

These basins show great number of erosion features of linear type and present very high and high susceptibility (classes I and II) as can be seen in Table 2 and Graphic 2.

Hydrological basins	Number of erosion features	Area (km ²)	Index of erosion features
Baixo Tietê	360	15.688,94	0,023
São José dos Dourados	238	6.508,48	0,037
Tietê/Batalha	458	13.143,41	0,035
Tietê/Jacaré	237	11.866,24	0,020
Sorocaba/Médio Tietê	260	11.865,75	0,022
Piracicaba/Capivari/Jundiá	332	14.242,31	0,023

Table 2 – Distribution of erosion features by hydrological basin.

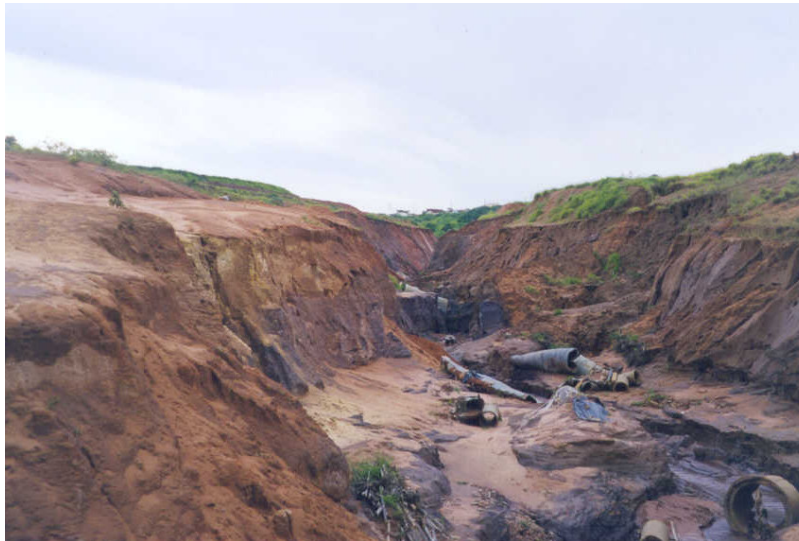
Picture 1 – Gully erosion situated in São Pedro municipality
(Archive IPT)

- Class I: Santa Bárbara D'Oeste, Sumaré, Ipeúna, Charqueada, São Pedro (Picture 1), Águas de São Pedro, Anhemi, Bofete and Botucatu;
- Classes II and III: Agudos, Bauru, Pirajuí, Balbinos, Itaju, Iacanga, Borborema, Taquaritinga, Cafelândia, Birigui, Araçatuba, Guararapes and Novo Horizonte.

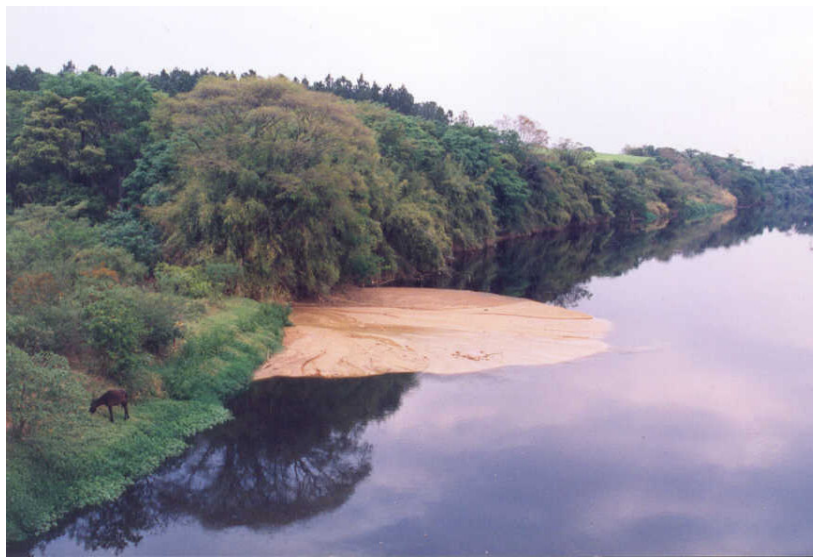
The environmental impact due to silting up process is very clear in many parts along the Tietê river and its affluents (Picture 2). It can be observed vast deposits of sediments along river channels. Most of them are recent sediment deposits composed by unconsolidated materials caused by man-made activities and prone to be retransported to lower points of the drainage system.

Picture 2 – Silting up in Piracicaba river caused by erosion from Santa Bárbara D’Oeste urban area (Archive IPT).
