ENVIRONMENTAL IMPACT OF URBANIZATION ON SANTA EULÁLIA SMALL FARM, SÃO LUÍS-MA, BRAZIL

Marina de Alcântara Rufino, Bsc. student in Eng. Agronomic - UFU
(marinar@netsite.com.br);

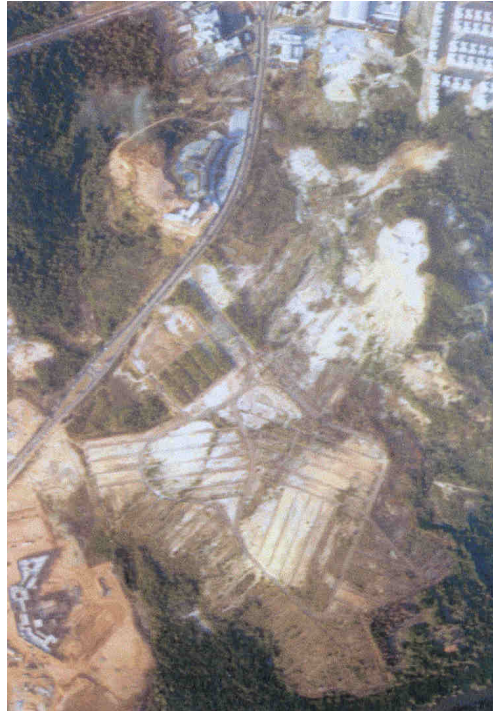
Santa Eulália small farm meets totally in the urban center of São Luís, it takes place only 8 km of the center and it has an access by the Avenue Carlos Cunha / Ponte Bandeira Tribuzzi. Currently, it fits an area of permanent protection, inserted in the diverse category of use, whose type of established occupation is the exposed soil, together with the degraded mangrove area, as it can be visualized in picture 1, (MARANHÃO, 1988).

Picture 1: Aerial sight of Santa Eulália small farm, source: SOBRINHO, 2002.

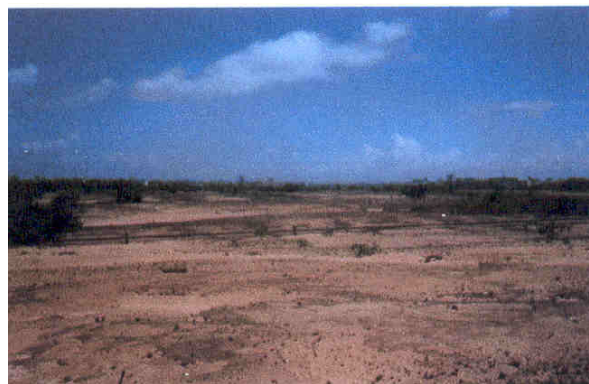
Its vegetal composition is the antropic nature of trees of average size and bushes characteristic and the herbaceous vegetation near to swamps, see picture 2.

Picture 2: Central part of Santa Eulália small farm, showing the vegetation.

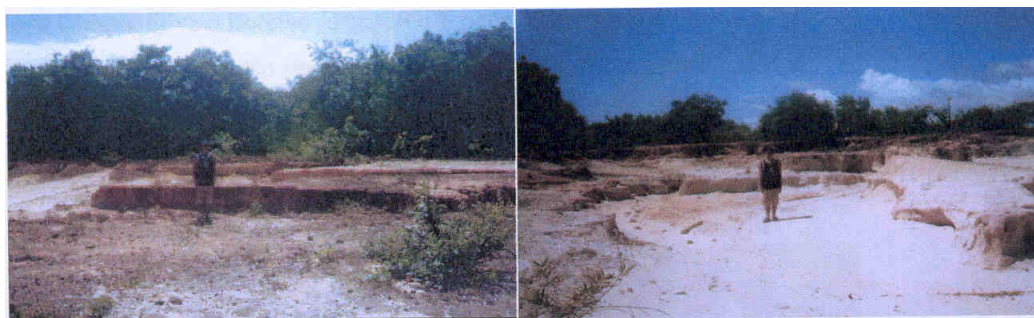
After the deforestation of great part of Santa Eulália small farm, the total ground was rummaged, which favored the appearance of gullies in some points of the small farm. Due to the stop of the work on half of the pavement of the housing development and the abandonment in the following years, it originated some foci of erosion - over all, in areas not vegetated, and the gullies that devolved had appearance in form of an open hand, to see figure 3. The gullies of Santa Eulália small farm are of antropic nature, result of the landscape transformation for real estate interests with the total cleanness of the area due to the withdrawal of trees processes and embankment.

Picture 3: Gullies of antropic nature in Santa Eulália small farm.

The gullies of the small farm possess dynamics in function of the rain, once that the vegetal covering inhibits the action of the winds and the effect of "splash".

The gullies of Santa Eulália small farm are of antropic nature, result of the landscape transformation for real estate interests with the total cleanness of the area by the withdrawal of trees processes and embankment.

- To protect the soil against the impact of the water of rain, coating the ground with vegetal covering for cushioning the rain drops. It presents advantage for being a cheap construction and the disadvantage occurs because it does not have the correction of the declivity of the barrier;

- To diminish the speed of the water, through the vegetal covering and/or mechanisms that facilitates the infiltration inside of the not erosive gradient. The canals of water division will have to be constructed in the above part of the gullies, 20 to 30 cm of its headboard, in a way that the superior abrupt declivity is well stabilized;

- To diminish the volume of waters in torrents consists of techniques that do not leave waters to join and to augment. The constructions can be of some forms such as: trenches that avoid erosion with function to hold back and/or to deviate the water; barrages of rocks; wire screen; stump of tree and leaves of plants in the gutter and in the sources of gullies.

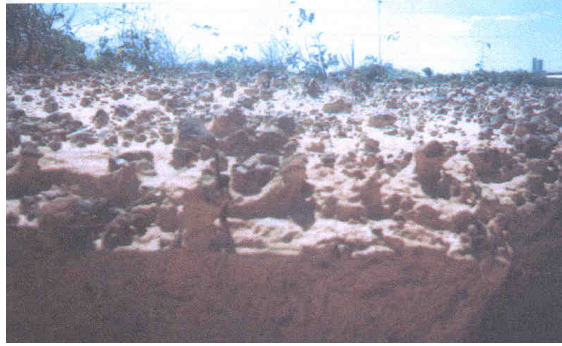
- Pedestals: sculptured nature by "splash" and the described superficial draining by GUERRA, SILVA & BOTELHO (1999), where the lateritic materials with varied sizes, hinders that the sediments that are situated right below are carried by the water, see picture 4.

Picture 4: Pedestals situated at the border of the gullies.

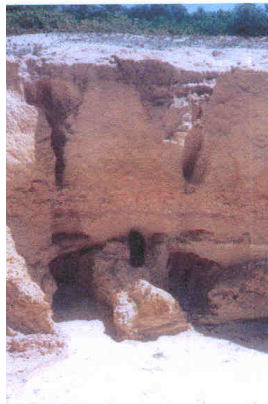
- Alcoves of regression: they are originated by the superficial and sub-superficial draining that can make the mass that concentrates above of the alcove falls down, thus, increasing the crack, see picture 5.

Picture 5: Alcoves of regression.
